New Fire Strategies in the Wake of Umoe Ventus

Annex A – Background study

OSK-ShipTech A/S

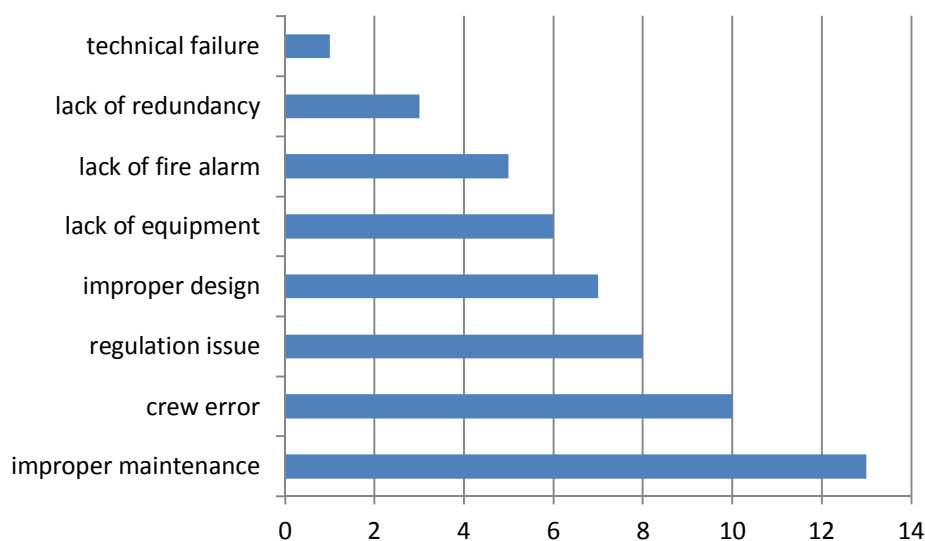
Figure 1 – Diagram ranking the various factors involved in the development of the fire events. The x-axis is the number of occurrences in the reviewed accidents.

Several stages of the life cycle of the ship (design, regulations, operation, maintenance, crisis management) are represented as decisive factors in the development of fire events. This highlights the tremendous knowledge gaps within the industry concerning composite materials. It also shows that regulations, which have been developed for shipbuilding with steel, are not ready to encompass new materials since the same safety principles as for steel are applied to materials behaving in an entirely different manner. By then, the requirement to reach a design "as safe as" a steel design does not give any basis to assessment. It could be more beneficial to state fire safety objectives and criteria which would have to be fulfilled.

Maintenance issues have an overwhelming predominance, since there are only 2 accidents where they are not involved. Discussions around fire safety on board composite ships usually focus on the design phase, on predicting what can happen to then mitigate the events, on drills (usually non-adapted to the material), but maintenance is left out. It appears from this analysis that maintenance plays a critical role in the start and development of fire, imposing to consider it as seriously as the building phase. Many accidents could be simply avoided if maintenance were carried out properly. It could be that maintenance errors should be considered as a relevant fire scenario during the design phase, and in the case of ships built with composite materials a relevant maintenance error can be the wrong fitting of insulation around a hot pipe leading to the ignition of a composite bulkhead (see Sea Gale #2, ECC Topaz #3, Jillian #8).
