# TEST REPORT LOADBEARING DECK

<b>Name of sponsor:</b>	Realdania By & Byg		
<b>Product name:</b>	MiniCO2 belastet dæk		
<b>File no.:</b>	PGA12165A	<b>Revision no.:</b>	0
<b>Test date:</b>	01-09-2022	<b>Date:</b>	14-07-2023
<b>Pages:</b>	10	<b>Encl.:</b>	42
<b>Ref:</b>	JBK / RKP

Examination of the fire-resistance of a loadbearing timber deck. See description for further details.

EN 1365-2:2014 Fire resistance tests for loadbearing elements - Part 2: Floors and roofs

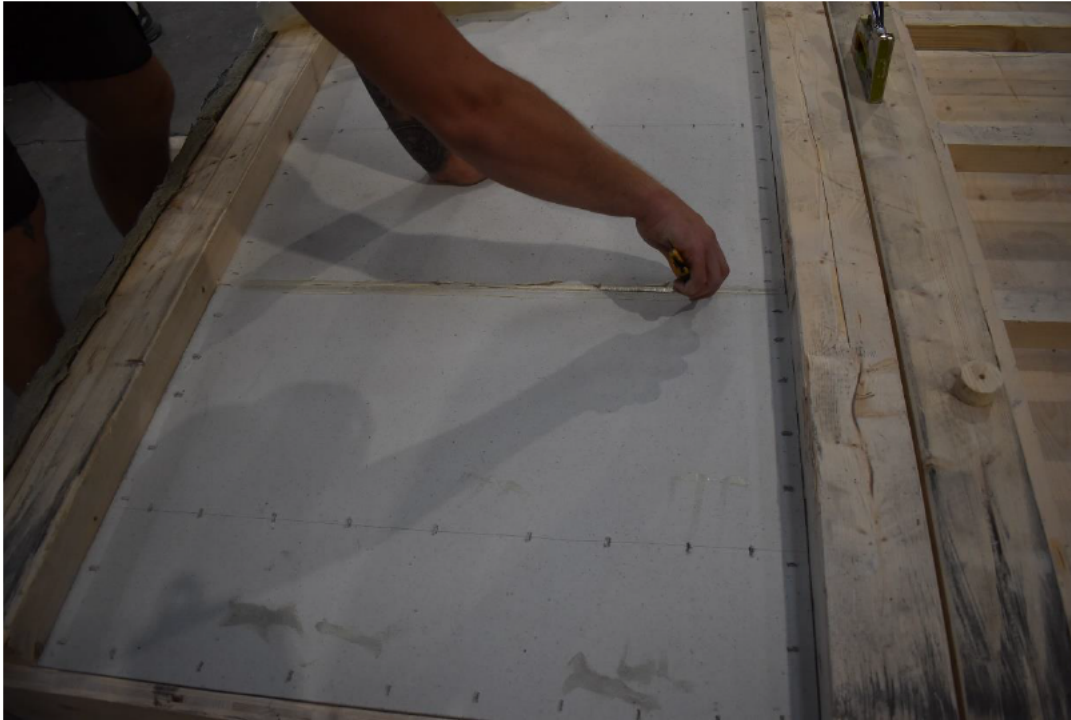
Photo No. 11 First two boards of the upper layer is being mounted. Glue residue from the accidentally glued gypsum joint is being removed.

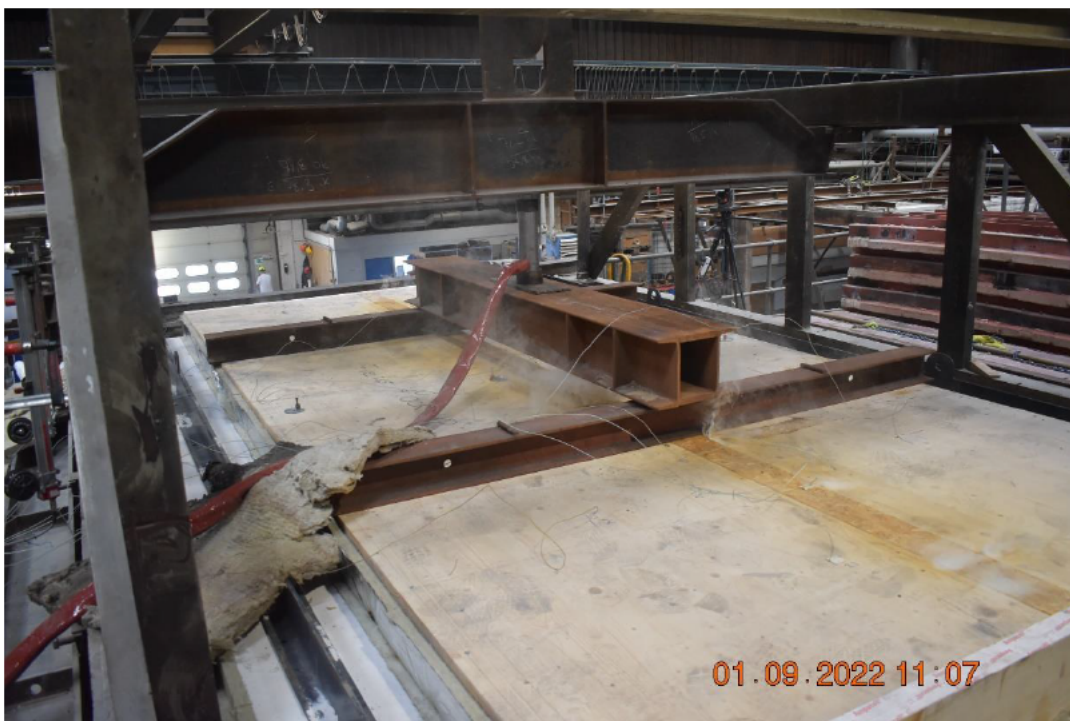
Time / Minutes	Visual observations:	U = Unexposed side E = Exposed side
0	Test commences	
1	Smoke development from the centre of short edges	U
2	Insulation of gaps in short edges with mineral wool starts	U
4	Insulation of gaps in short edges with wool is completed	U
9	Smoke development from the side of the short edge (right, right)	U
14	No fallen gypsum boards and timber have sharp edges	E
30	Faint smoke development from joints in the centre of the right load steel beam	U
41	Faint smoke development from the centre of the deck (from joint)	U
42	Yellow discolouration/moisture left of the left load steel beam	U
44	Faint smoke development from left of left beam	U
45	Increased smoke development from right beam	U
46	Smoke development increases around right load steel beam	U
51	Cracks width approx. 2-3 mm, along the whole top long edge	U
57	Thicker yellow tinted smoke development from the centre of deck	U
58	Hanging gypsum board on left side of the specimen	E

Photo No. 26 Test specimen after 60 minutes of testing

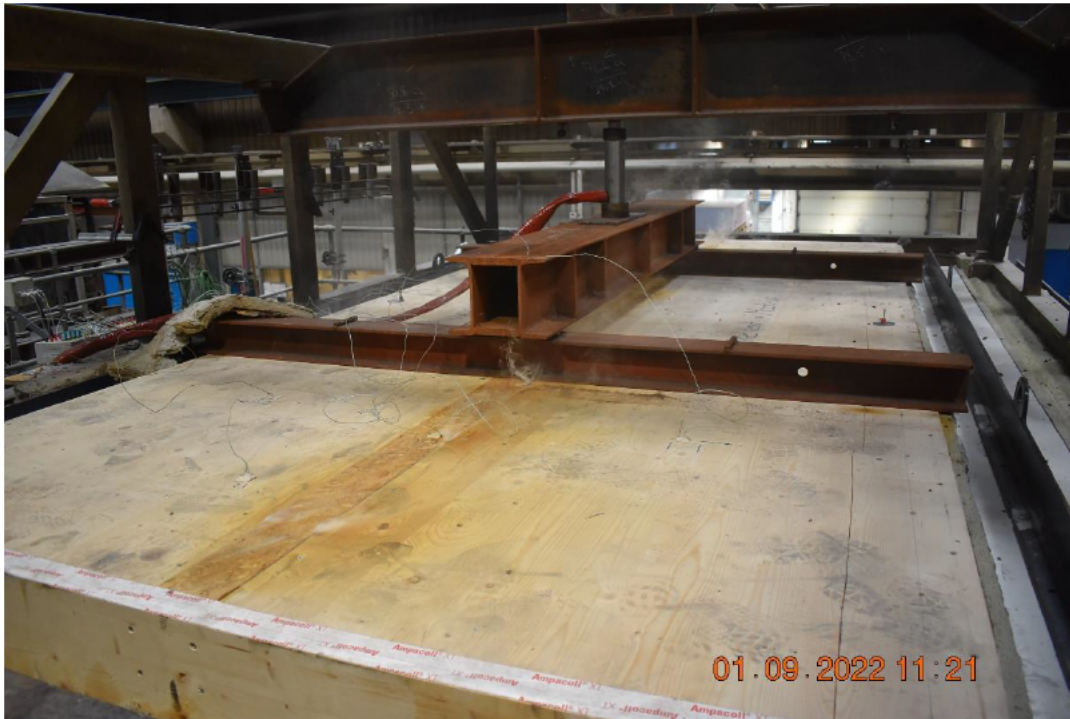
62	Smoke development decreases in general	U
68	Large piece of the bottom gypsum layer has fallen on the left side	E
73	Larger piece of the first layer has fallen on right side	E
74	Cracks in top layer of CLT	U
75	Increased smoke development from left side of centre	U
77	More gypsum has fallen on right side	E
86	Approximately 80 % of the top gypsum board layer is exposed	E
89	Upper gypsum layer has started fall on right side	E
93	Loud sound of timber charring	U

Photo No. 27 Test specimen after 74 minutes of testing

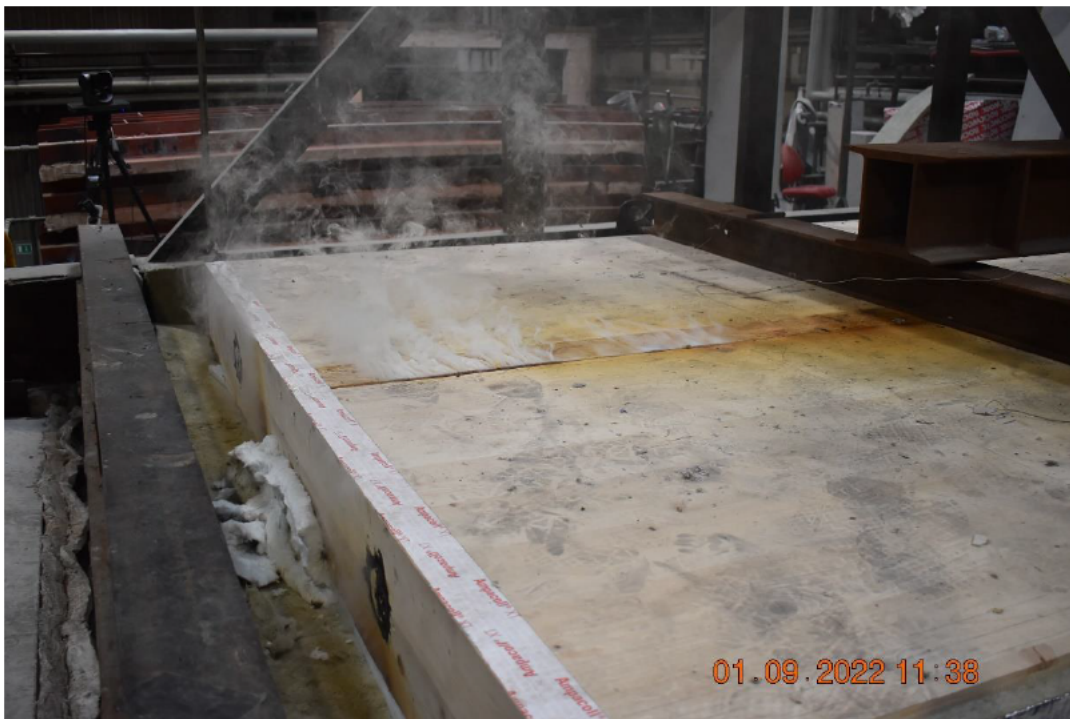
Photo No. 28 Test specimen after 91 minutes of testing

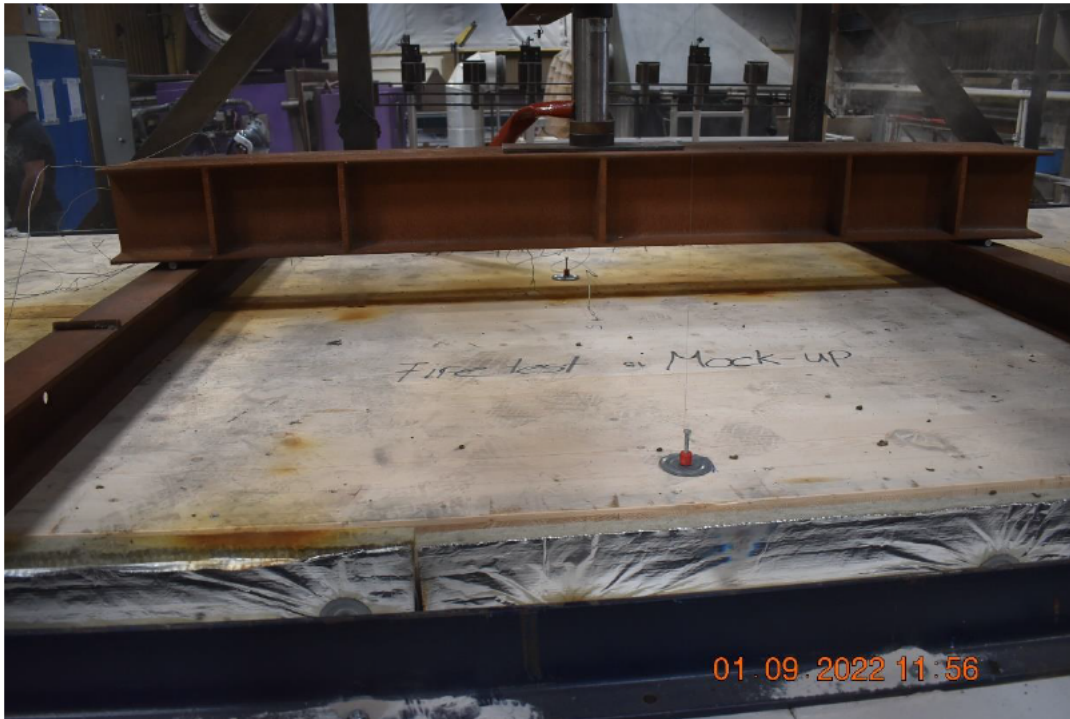
95	Upper layer has fallen in more places	E
97	Approximately 20 % of upper layer have fallen or are hanging	E
104	Paper wool insulation is falling in smaller chunks	E
110	Test stopped, due to health and safety reasons

Photo No. 29 Test specimen after 109 minutes of testing

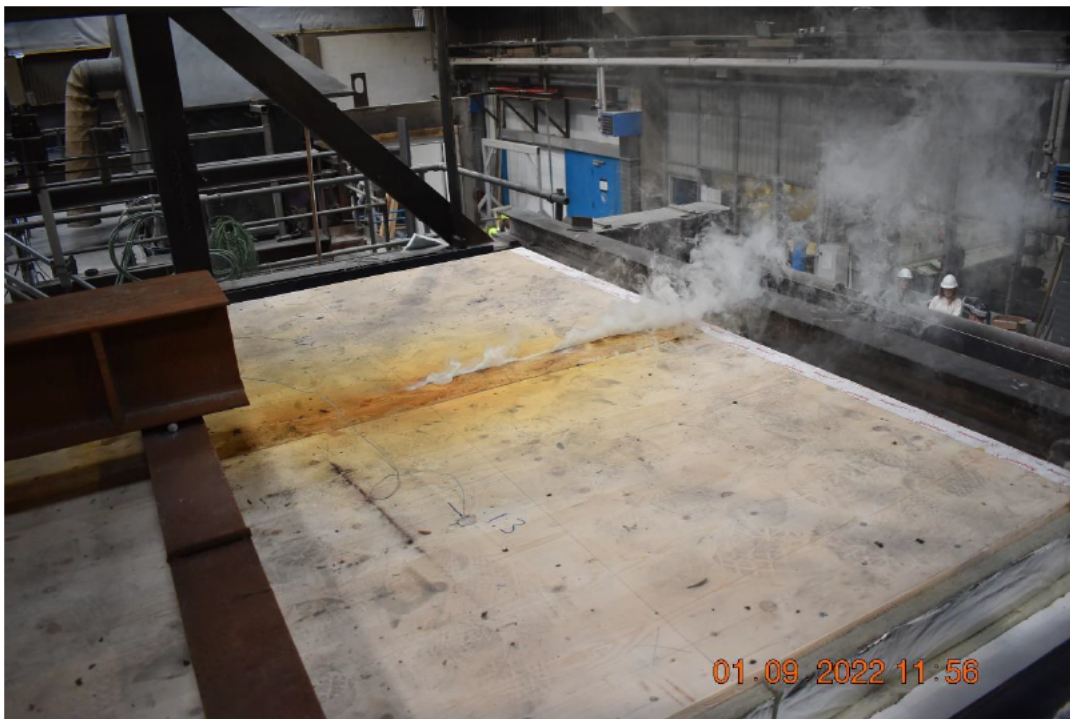
Photo No. 30 Test specimen after 109 minutes of testing

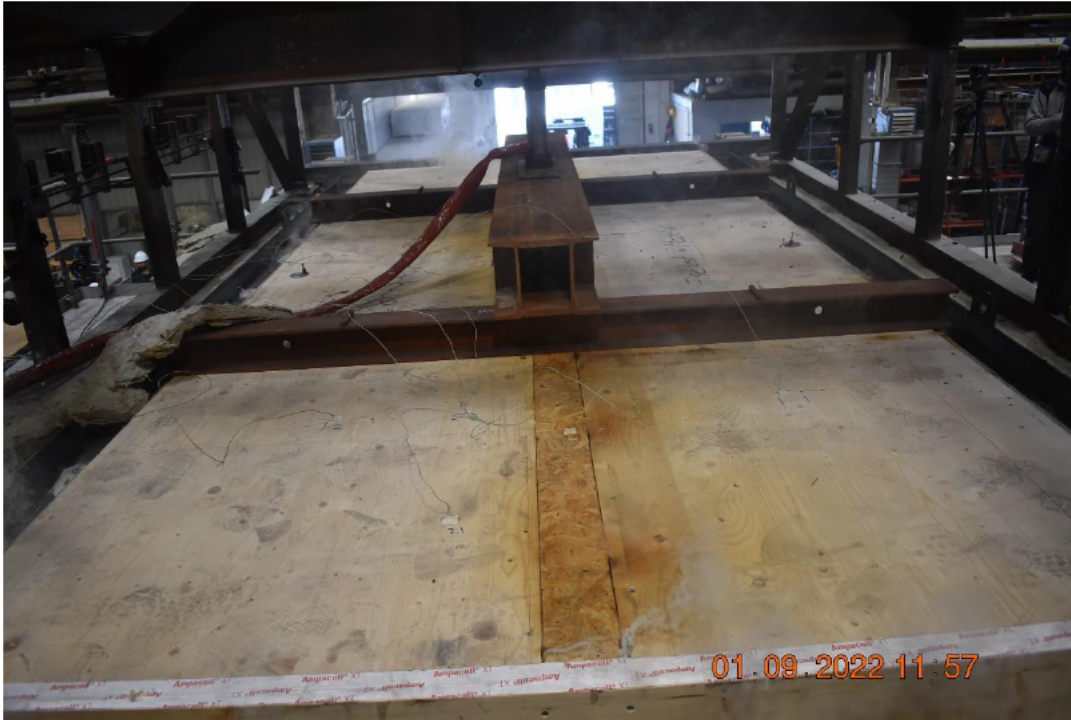
Photo No. 31 Test specimen when the test is stopped after 110 minutes of testing

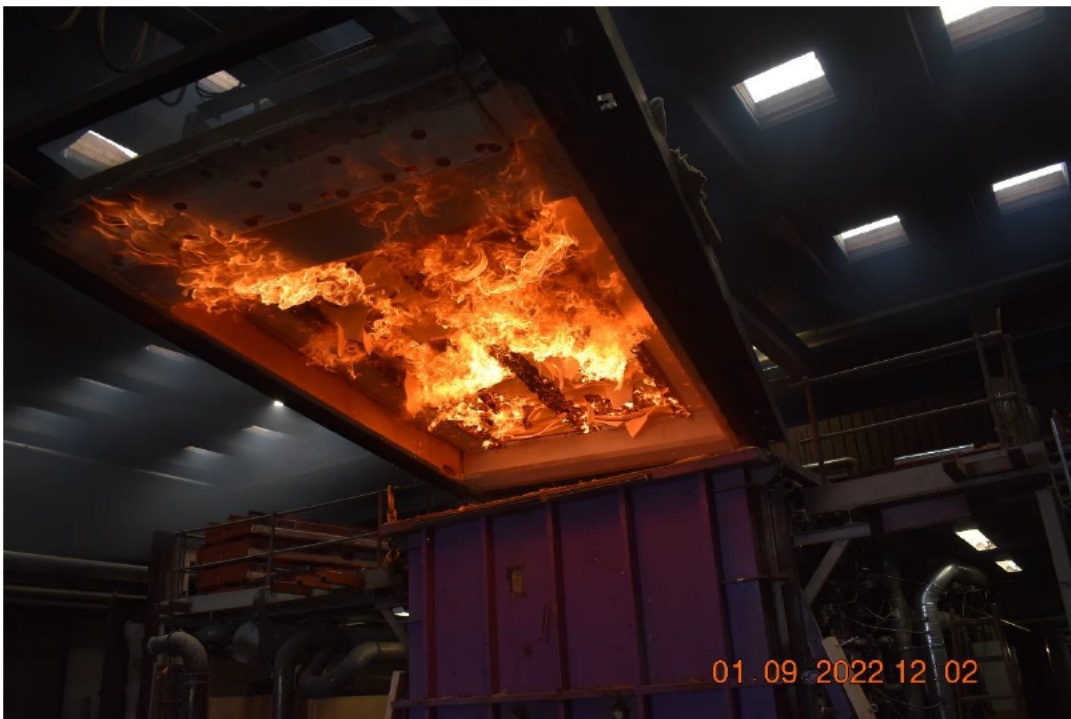
Photo No. 32 Exposed side when the test specimen is removed from the furnace, five minutes after test is stopped

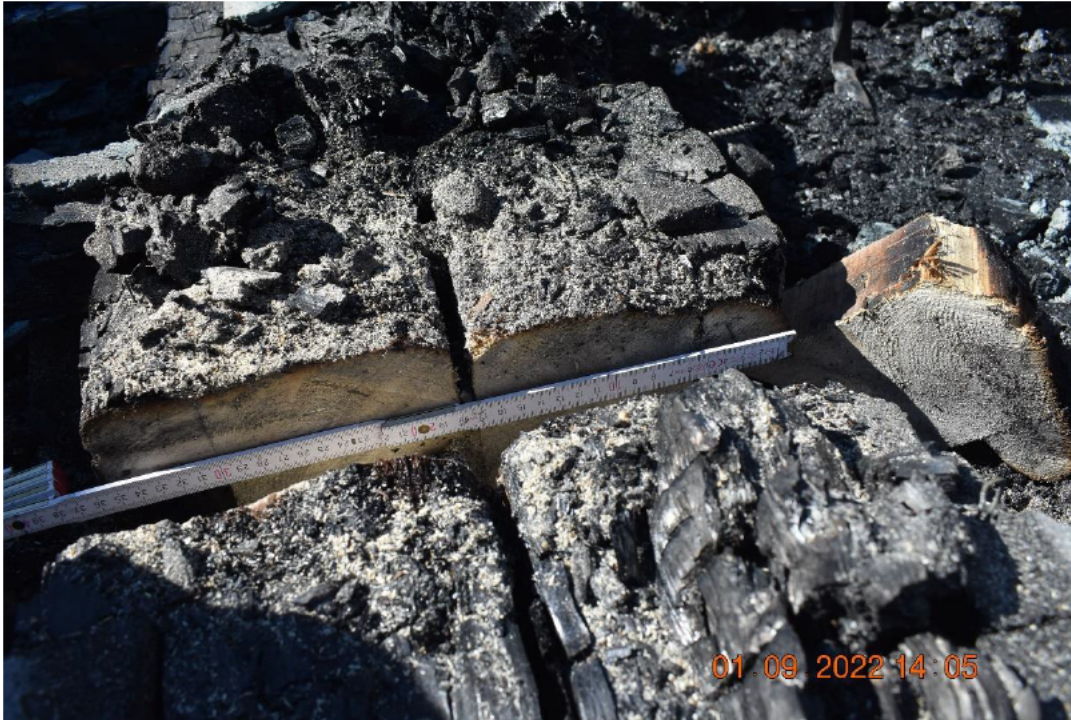
The cross section of the timber beams were measured to 12 x 15 cm after the fire test.

Photo No. 35 Charring of centre timber beams after test

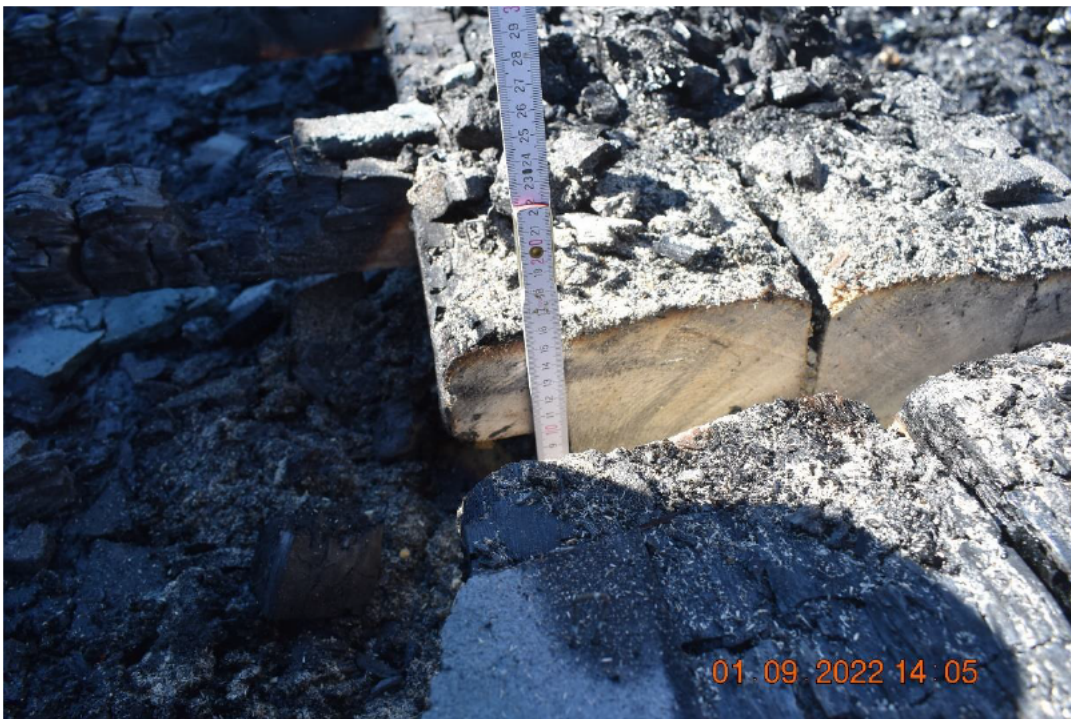
Photo No. 36 Charring of centre timber beams after test
