TEST REPORT LOADBEARING WALL

Name of sponsor:	Wood:UpHigh		
Product name:	Loadbearing wall		
File no.:	PGA12210A	Revision no.:	1
Test date:	2022-11-30	Date:	04-07-2023
Pages:	10	Encl.:	48
Ref:	JBK / CHB

The test specimen has been subjected to a standard fire test in accordance with the following standards:

EN 1365-1:2012 Fire resistance tests for loadbearing elements — Part 1: Walls

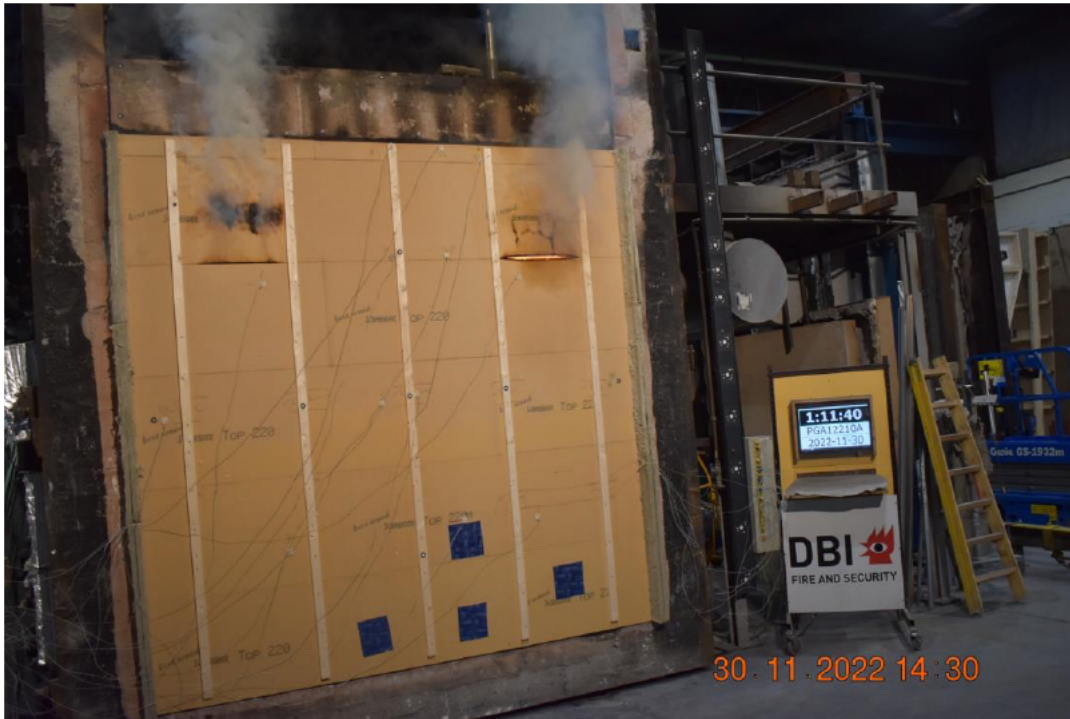
Photo No. 17 Test specimen seen from unexposed side 71 minutes into the test

71	5 mm gap gauge could pass through the construction for more than 150 mm	U
72	Sustained flames from horizontal joint	U
72	Test stopped

- Sustained flaming occurred after 72 minutes of testing
- The cotton pad was not ignited during the test.
- A through-going opening was created during the test where a 5 mm gap gauge could pass for more than 150 mm after 71 minutes of testing

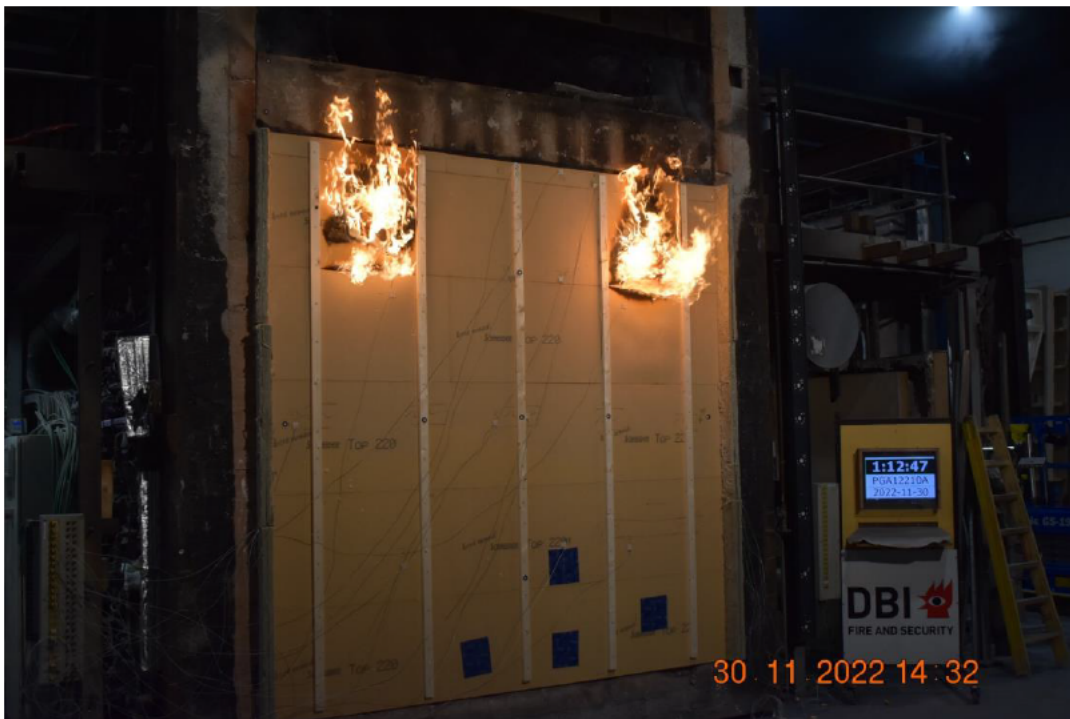
Photo No. 18 Test specimen seen from unexposed side 72 minutes into the test

Load-bearing capacity (R): **72 minutes**

- Failure of insulation occurred after 71 minutes of testing due to failure of integrity
- The average temperature rise on the unexposed surface of the test specimen did not exceed 140°C during the test. The highest average temperature rise during the test was 74°C in the 72th minute.
- The maximum temperature rise on the unexposed surface of the test specimen did not exceed 180°C during the test. The highest maximum temperature rise during the test was 61°C in the 72th minute.
