TEST REPORT NON-LOADBEARING WALL

Name of sponsor:	Wood:UpHigh		
Product name:	Non-loadbearing wall		
File no.:	PGA12234A	Revision no.:	0
Test date:	2023-01-27	Date:	2023-07-10
Pages:	9	Encl.:	41
Ref:	JBK / CHB

Examination of the fire-resistance of one symmetrical partition wall with timber frames.

The test specimen was a double timber frame construction with gypsum boards, particle boards and grass fiber insulation. The test specimen was symmetrical.

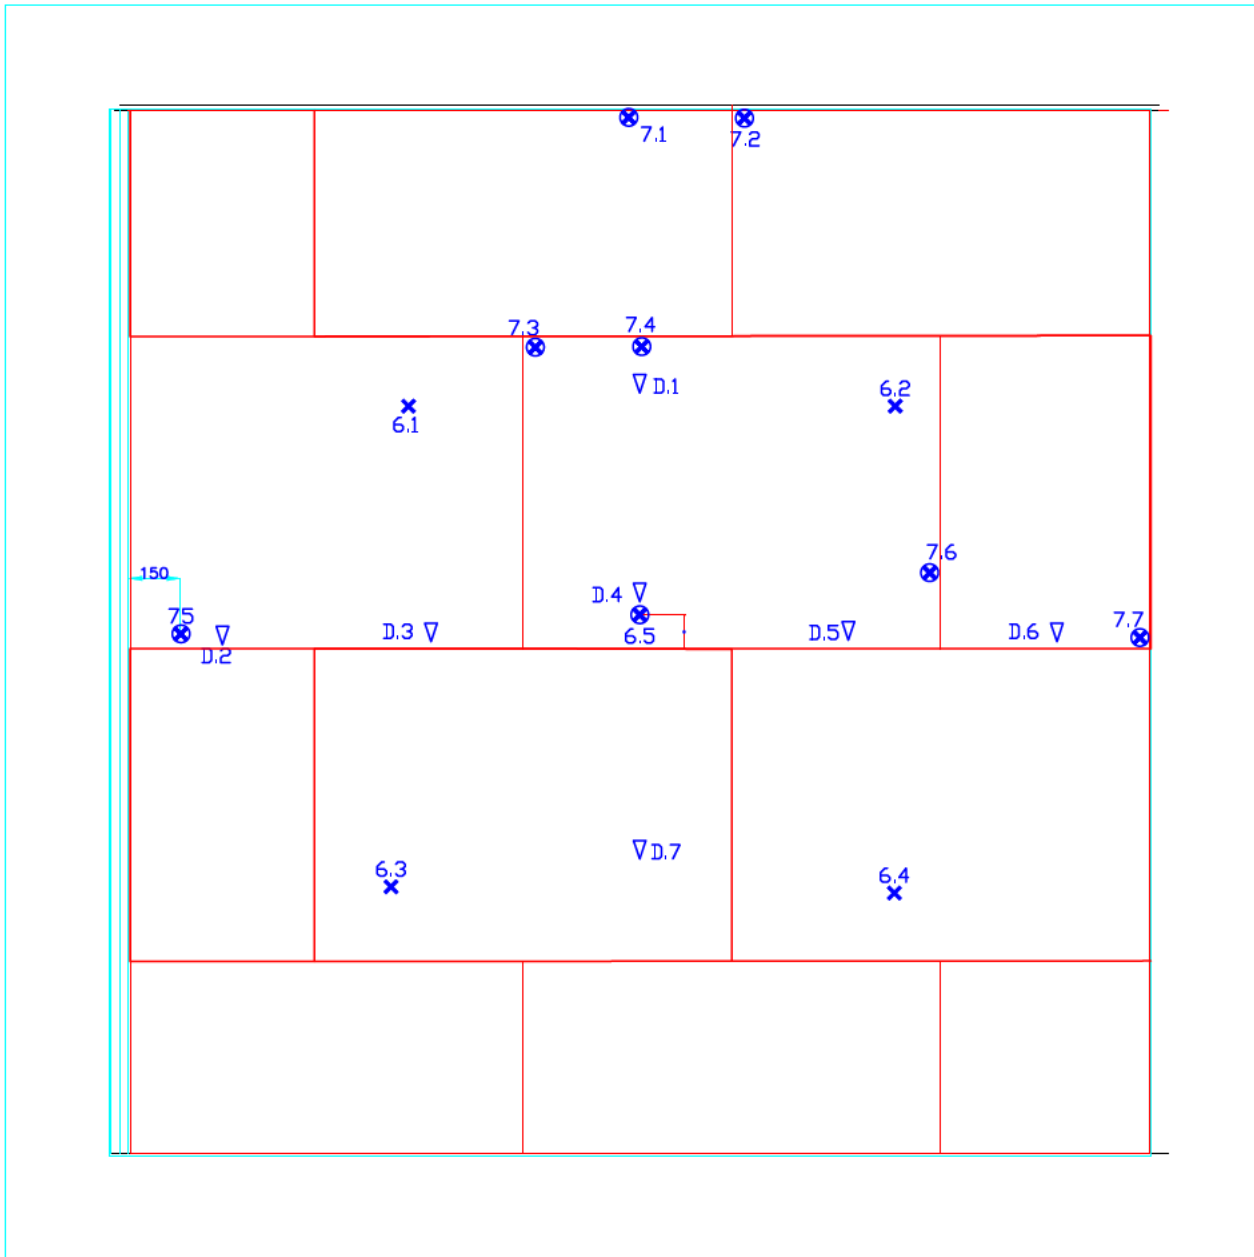
Enclosure: 1.0

The surface temperatures were measured on the unexposed surface of the test specimen as indicated on DBI drawing no. 1.0-1.6.

- ✕ Thermocouple placed on the unexposed surface (average)
- ⊗ Thermocouple placed on the unexposed surface (maximum)
- ∇ Deflection measuring point

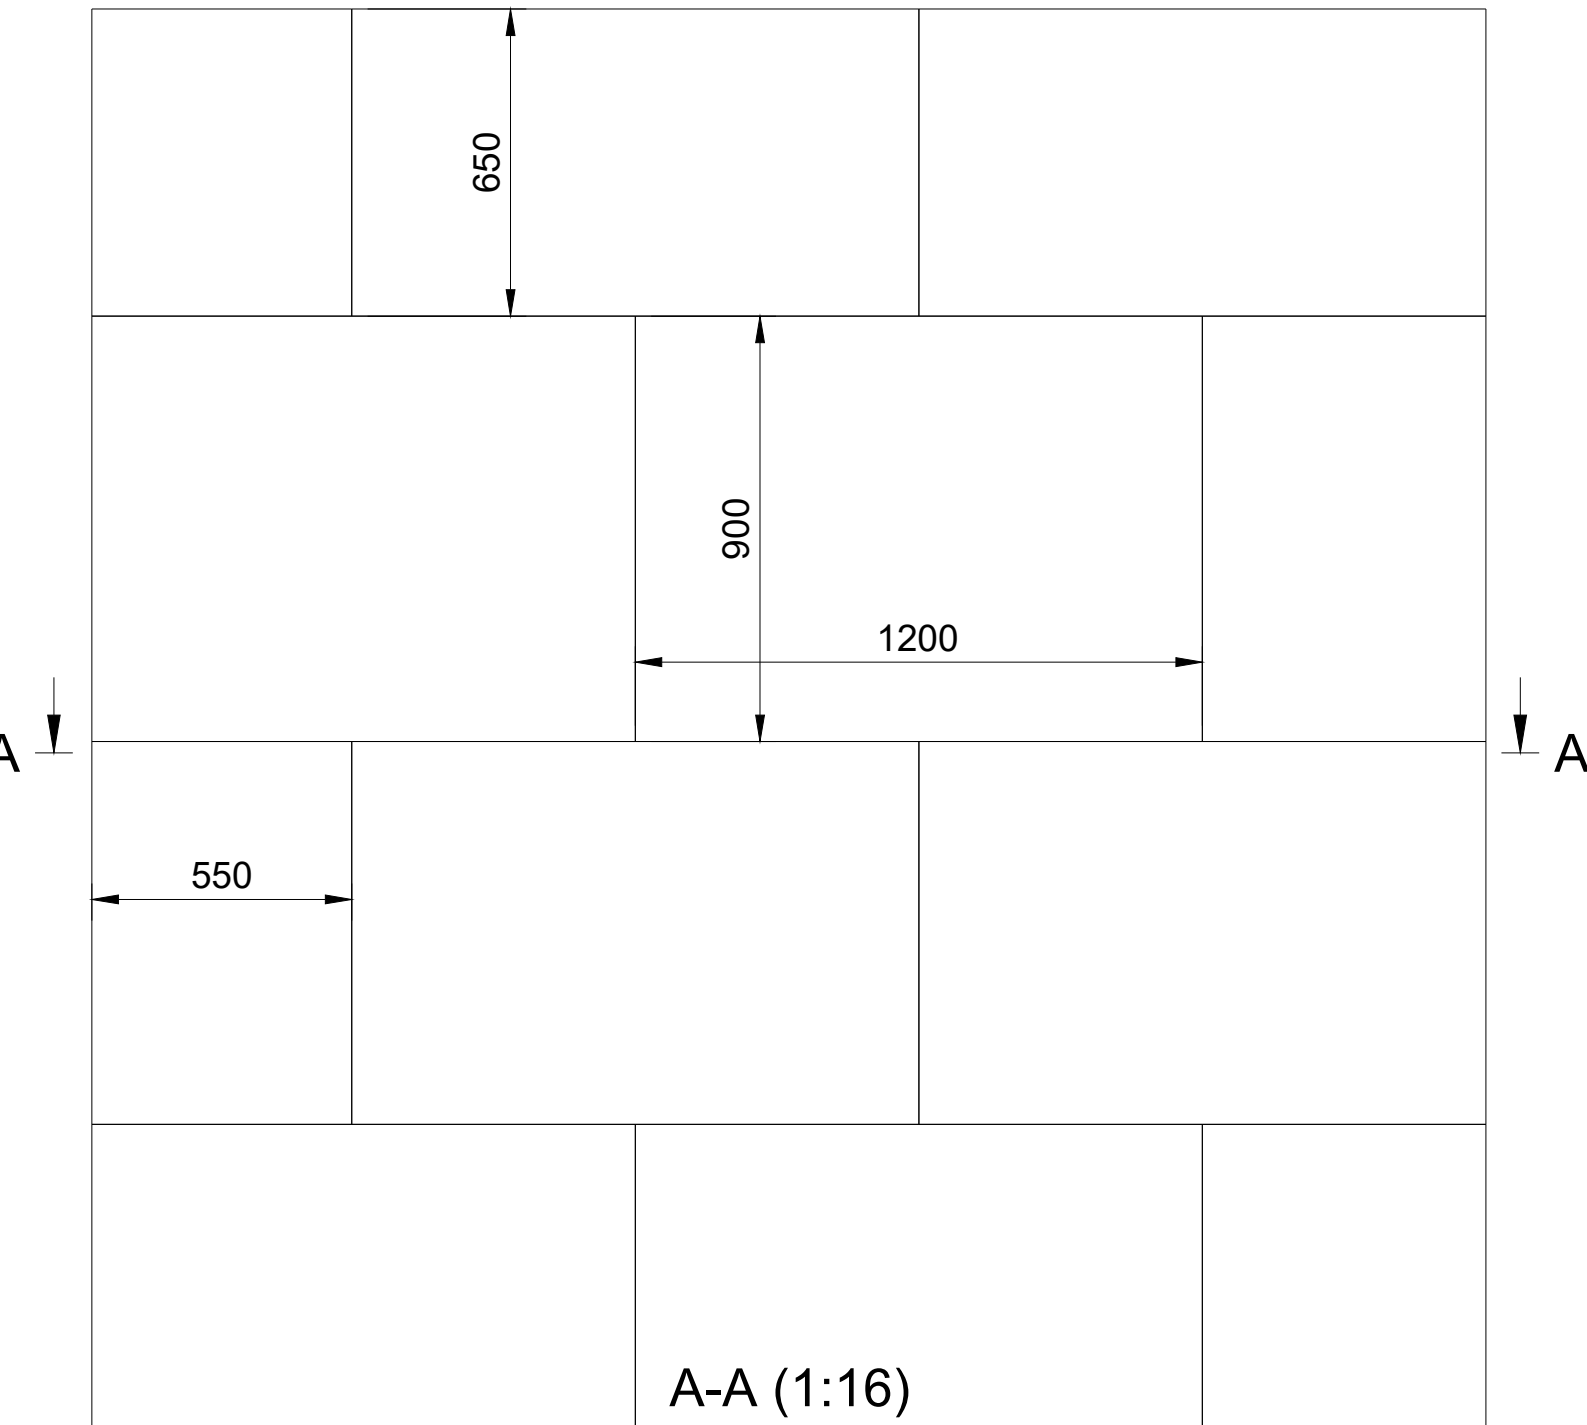
File No.: PGA12234A
Test date: 27-01-2023
Enclosure: 1.1

Danish Institute of Fire and Security Technology
 Sponsor: Wood:UpHigh
 Subject: Non-loadbearing wall - Unexposed side

See drawing no. 1.1 and 1.2 and photo no. 1.

See drawing no. 1.1.

See drawing no. 1.1 and 1.6 and photos no. 5 and 9.

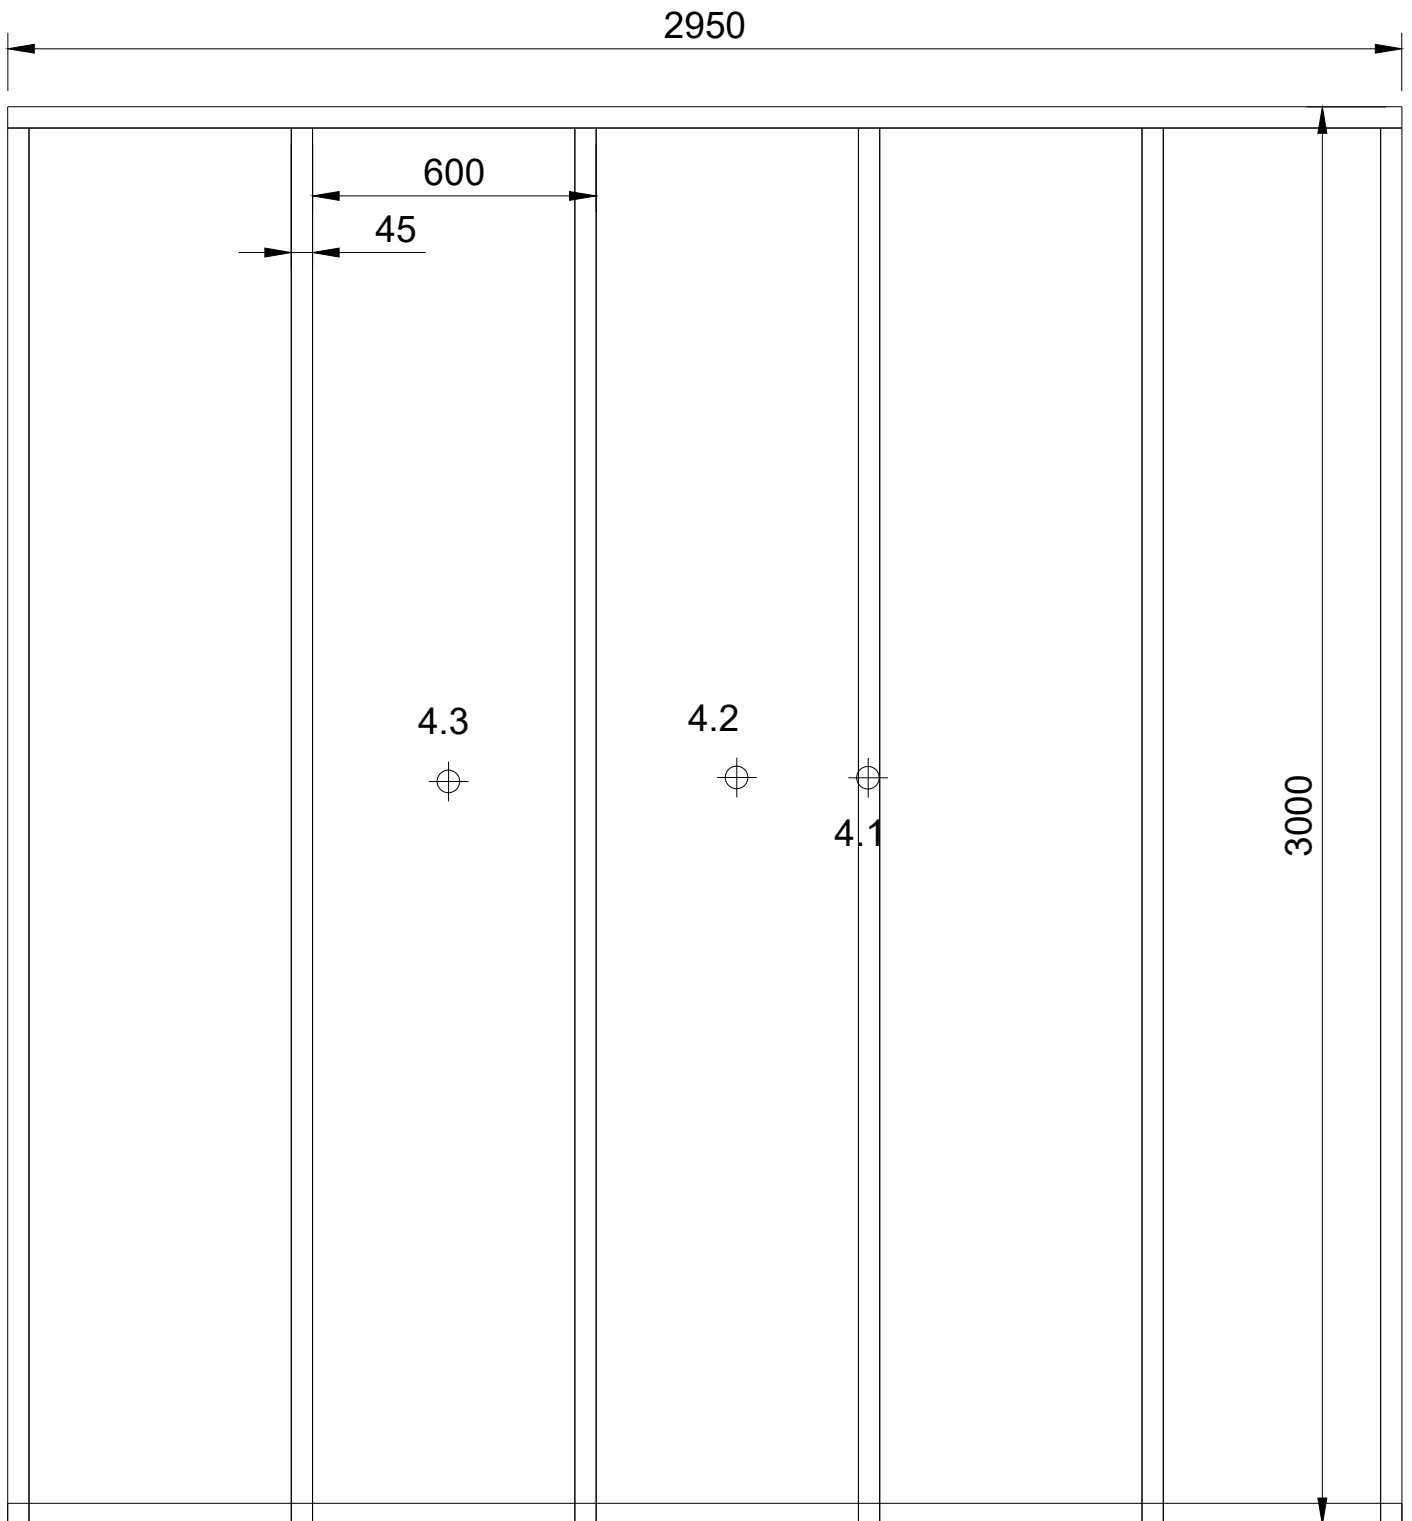
Enclosure: 1.3

Subject: Non-loadbearing wall - Unexposed side - wood structure with insulation

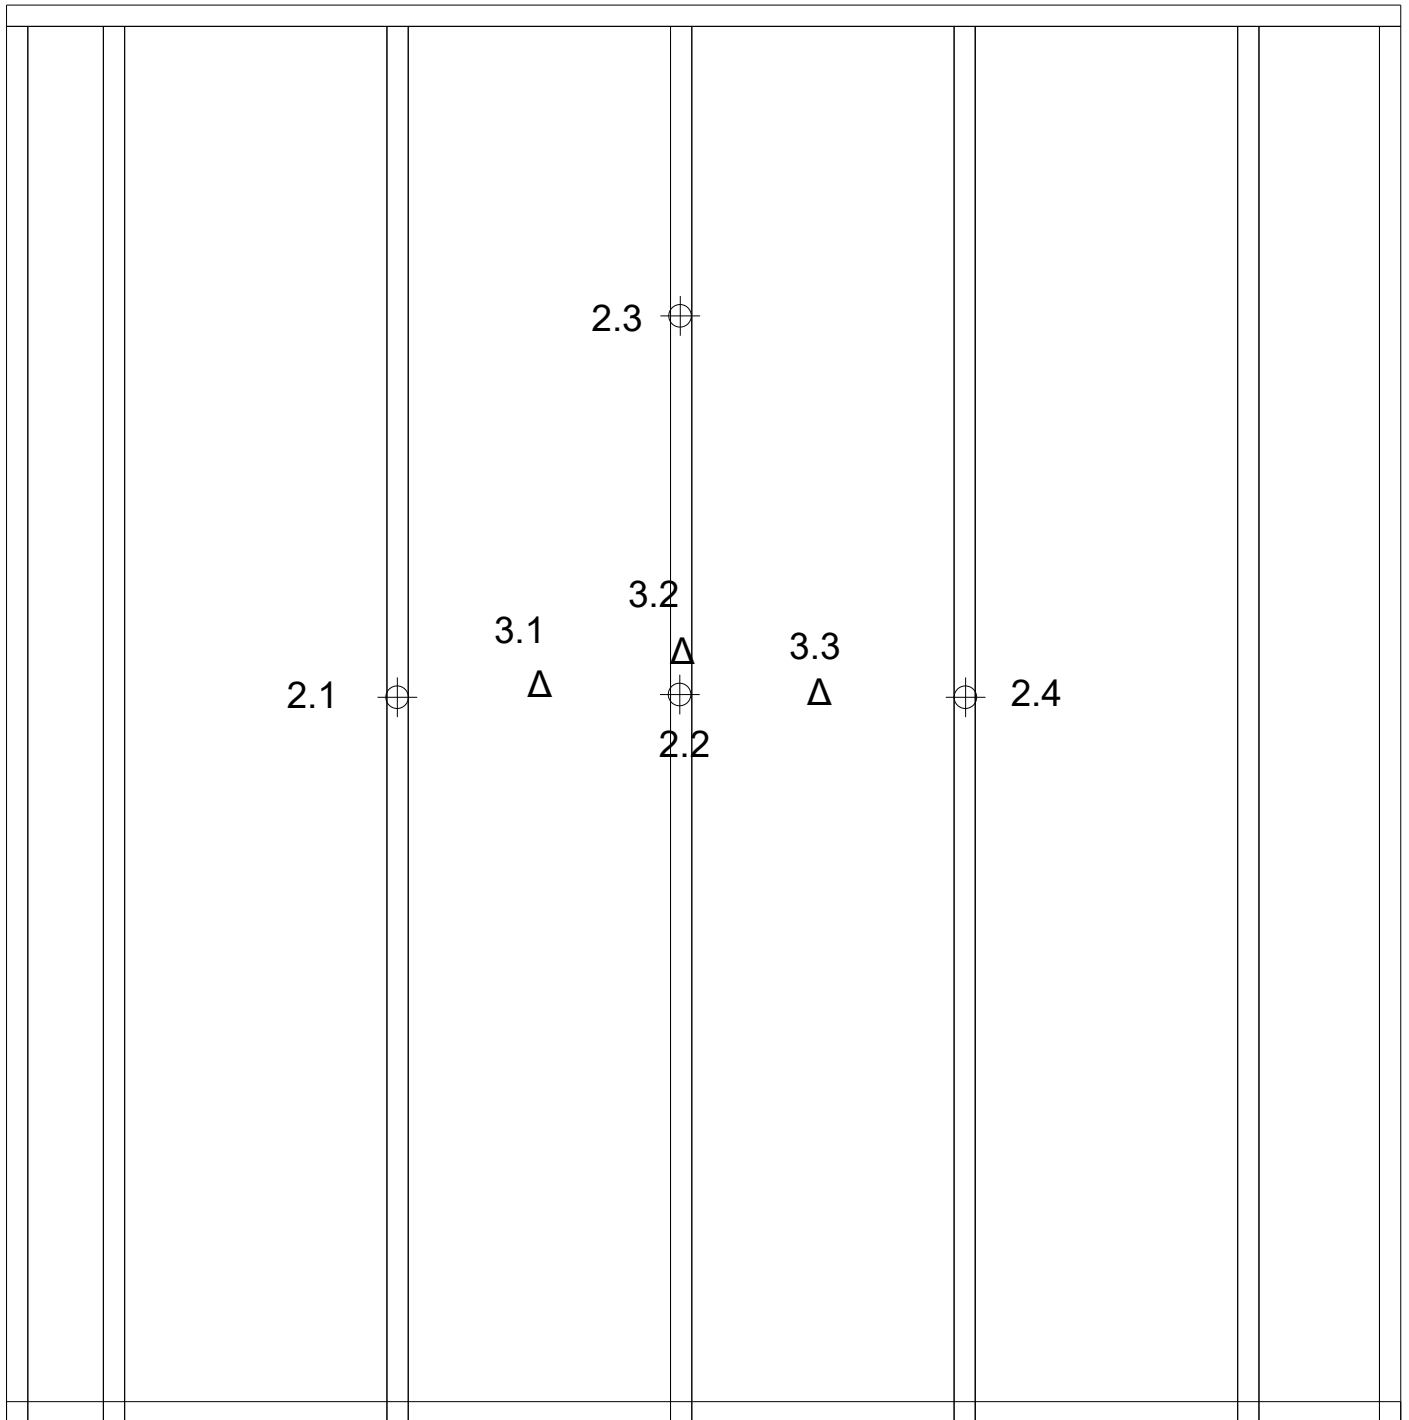
Enclosure: 1.4

⊕ Thermocouples placed between wood structure and wooden chipboard

Δ Thermocouples in air gap between wood structures

Subject: Non-loadbearing wall - exposed side - wood structure with insulation

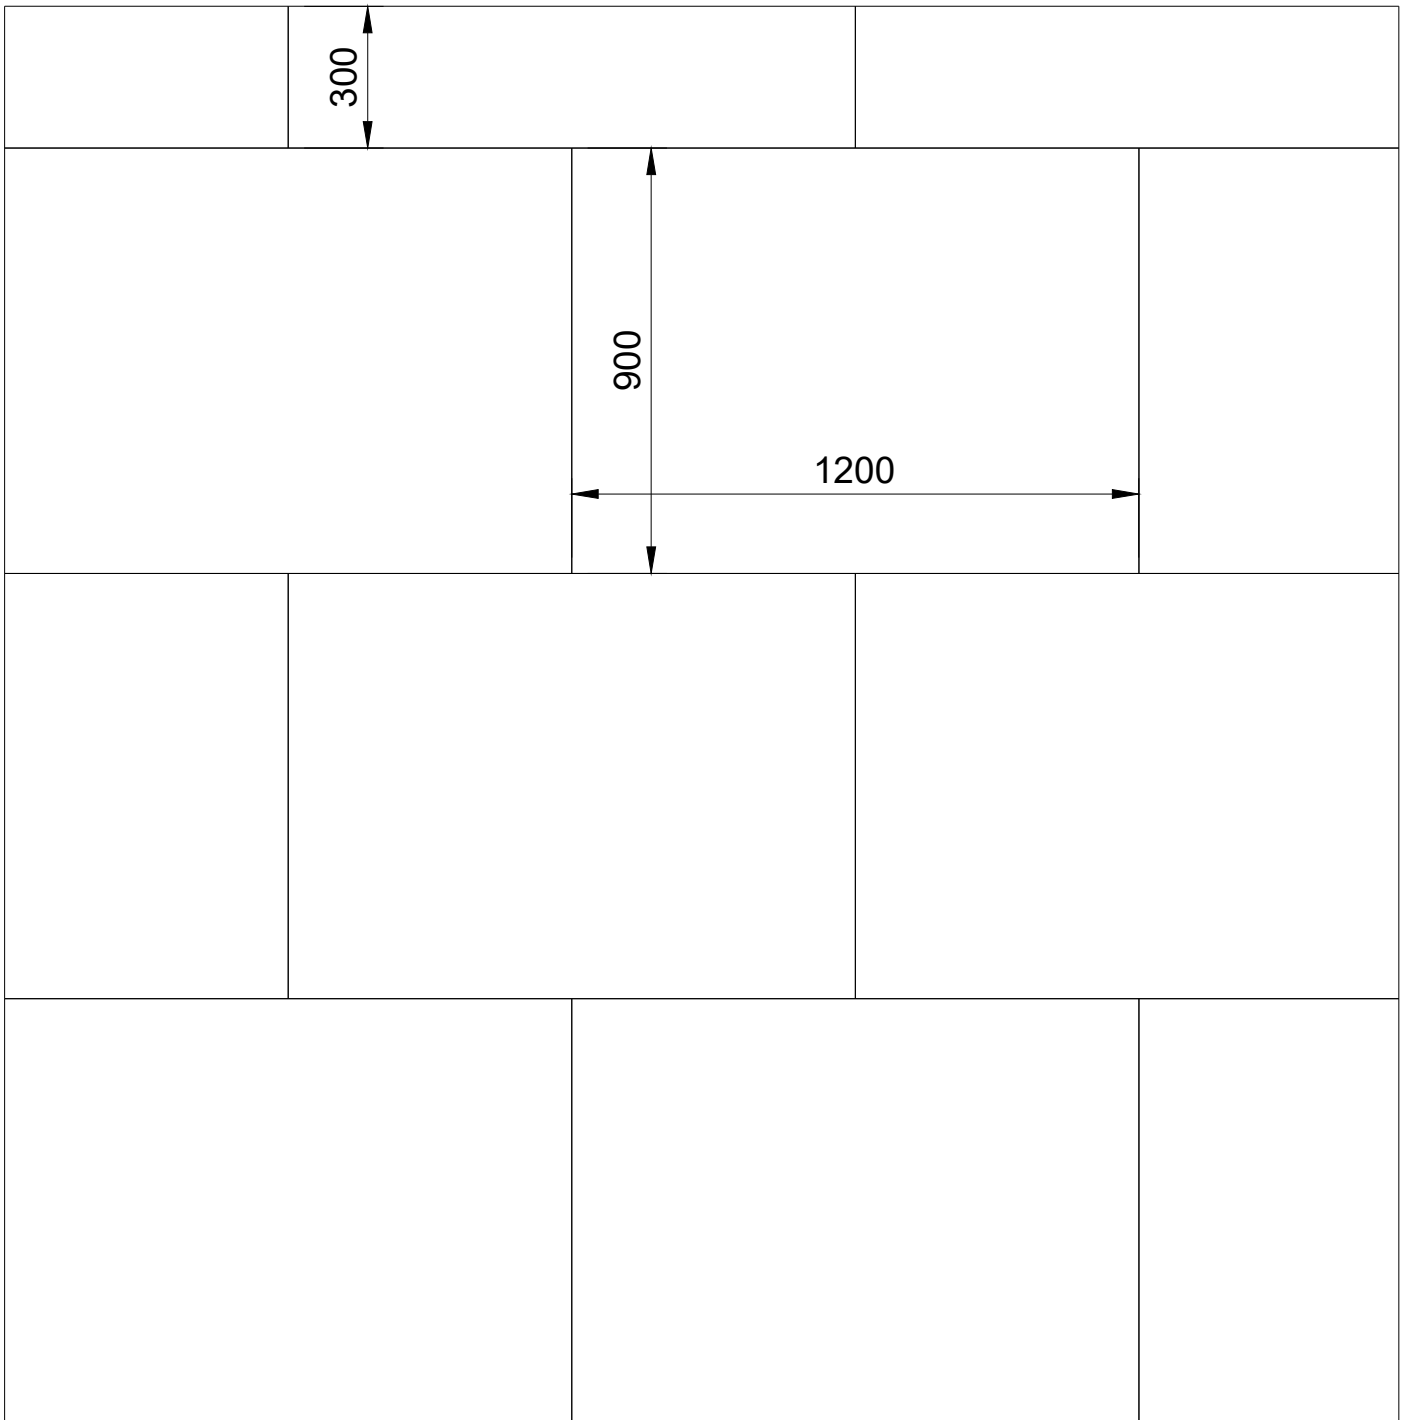
Enclosure: 1.6

Subject: Non-loadbearing wall - exposed side - outer layer of boards

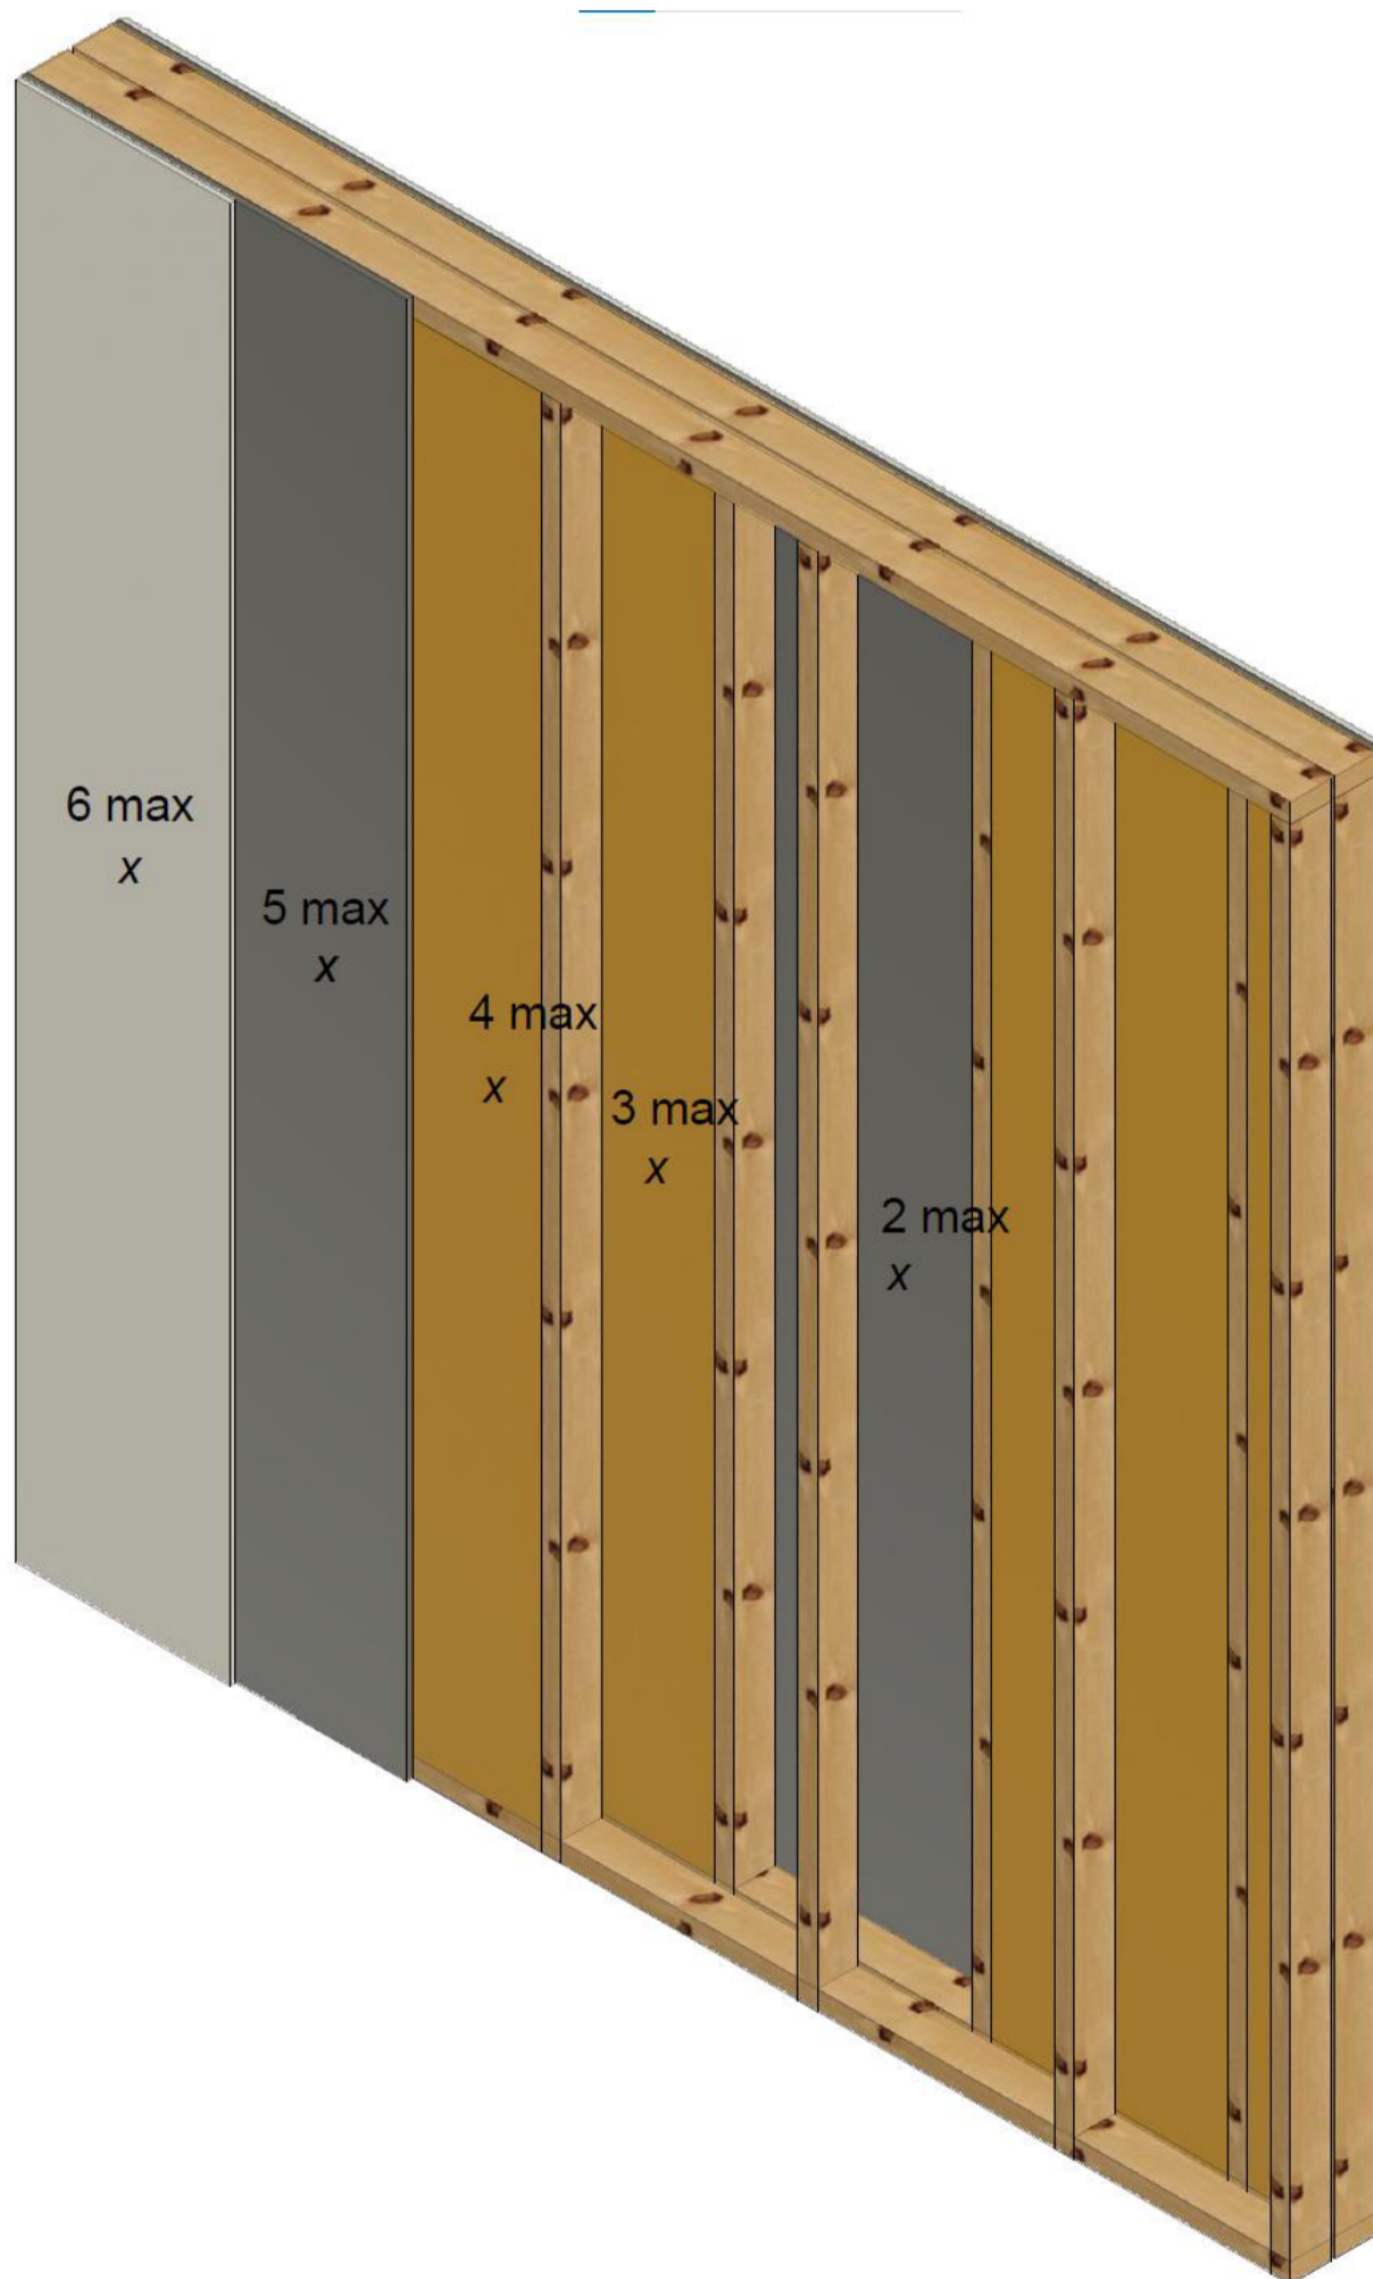
Thermocouples measure temperature between layers
0 : fire curve
1 : between fiber gypsum and woodboard
2 : between wood board and wooden studs
3 : between insulation layers
4 : between insulation and wood board
5 : between wood board and fiber gypsum
6 : unexposed side
7 : Unexposed side

Enclosures 9.0 and 9.1	Internal temperature - between studs and chip board Unexposed Mid height, 1 on third stud from right, 2 and 3 on insulation to the left of 1 seen from unexposed side
Enclosures 10.0 and 10.1	Internal temperature - between insulation layers at mid height, 1 and 3 on insulation, 2 on center stud seen from exposed side.
Enclosures 11.0 and 11.1	Internal temperature - between studs and chipboard exposed 1,2 and 4 on second stud at mid height, 3 on center stud at height 2460 mm seen from exposed side
Enclosures 12.0 and 12.1	Internal temperature - Between chipboard and fiber gypsum Exposed placed in 1/4 points between chipboard and fibergypsum
Enclosures 13.0 and 13.1	Maximum temperature between the construction layers Each data serie corresponds to the maximum temperature of all thermocouples in that layer. See drawing 1.7

Each data serie corresponds to the maximum temperature of all thermocouples in that layer. See drawing 1.7

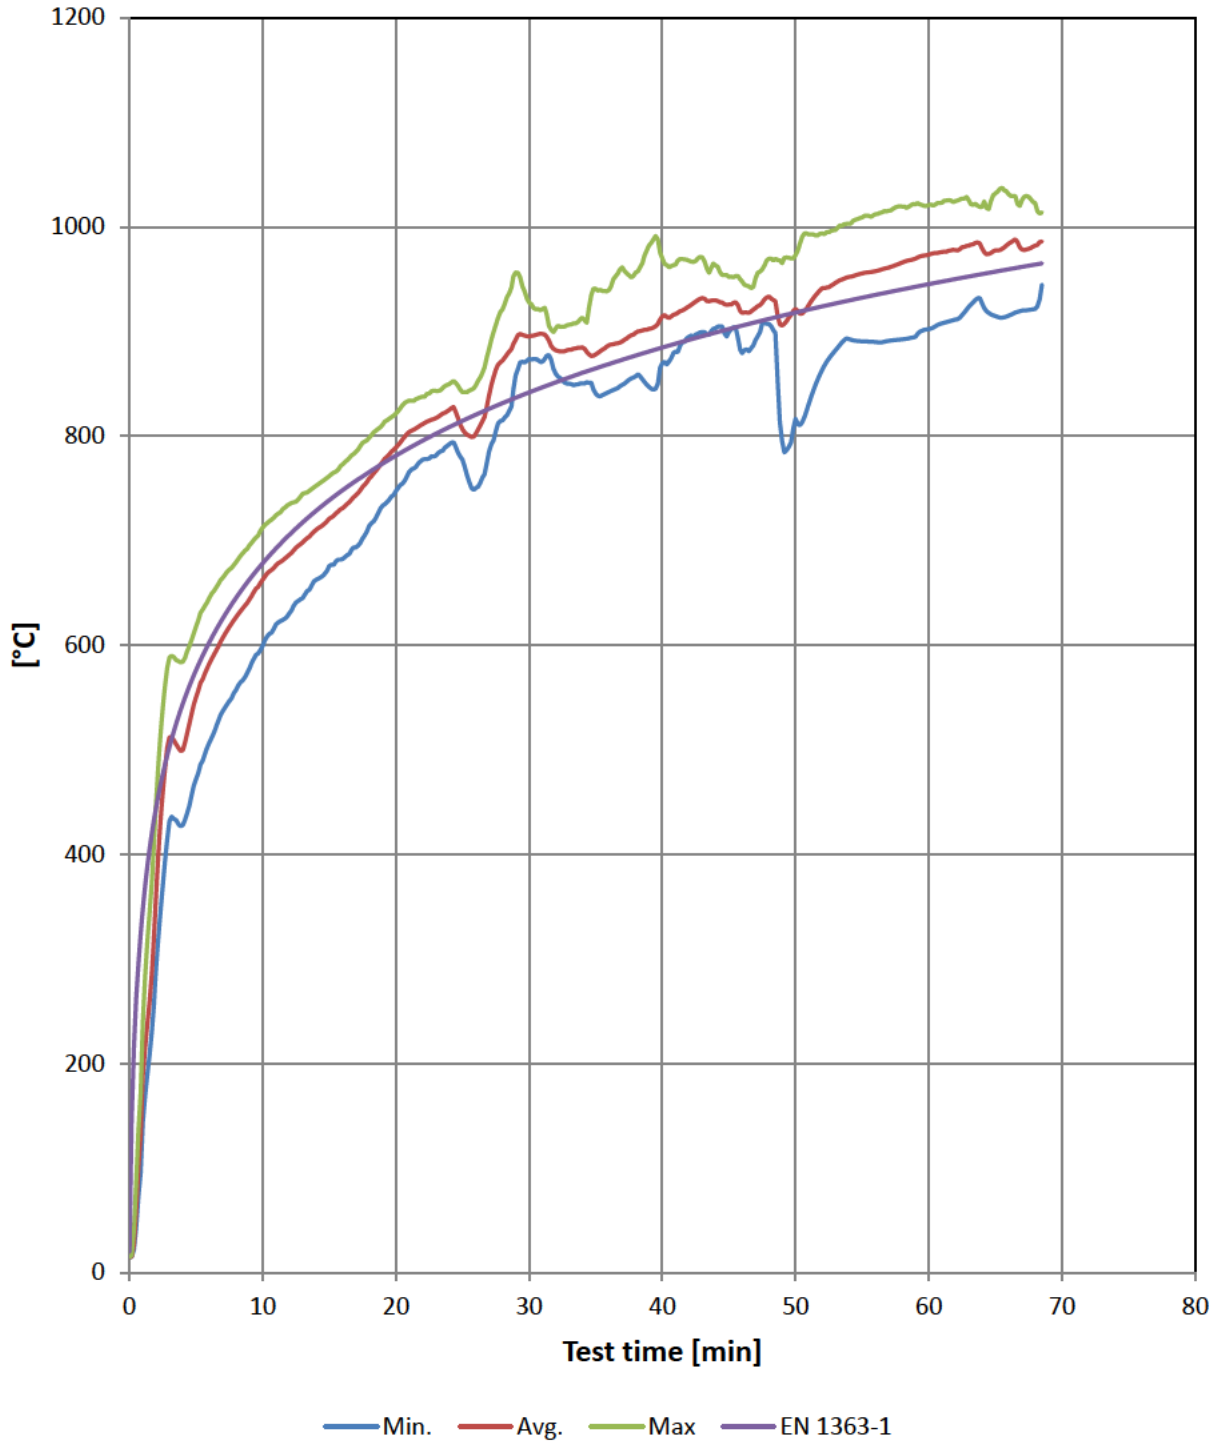
Furnace temperature

Time Minutes	Measured			Norm	Area under curve		Dev. [%]	Limit [%]
	Minimum	Average	Maximum	EN 1363-1	Measured	EN 1363-1		
0	15	15	15	20	0	0	0.0	
2	288	361	450	445	338	640	-47.2	
4	428	500	584	544	1294	1639	-21.0	
6	507	583	645	603	2387	2790	-14.5	15
8	557	627	679	645	3599	4041	-10.9	15
10	600	662	712	678	4888	5366	-8.9	15
12	631	686	735	705	6239	6750	-7.6	14
14	663	710	752	728	7636	8185	-6.7	13
15	676	721	761	739	8351	8918	-6.4	13
16	683	731	773	748	9077	9662	-6.0	12
18	714	760	799	766	10565	11176	-5.5	11
20	747	789	822	781	12115	12723	-4.8	10
22	777	811	838	796	13719	14300	-4.1	9
24	792	825	850	809	15355	15904	-3.5	8
26	751	802	849	820	16977	17534	-3.2	7
28	815	872	921	832	18653	19186	-2.8	6
30	874	895	928	842	20431	20859	-2.1	5
32	860	882	903	851	22218	22552	-1.5	5
34	850	885	913	860	23983	24264	-1.2	5
36	842	887	940	869	25745	25994	-1.0	5
38	857	899	957	877	27529	27740	-0.8	4
40	870	914	970	885	29336	29502	-0.6	4

The furnace temperature was determined by means of plate thermocouples uniformly distributed at a distance of approximately 100 mm from the exposed side of the test specimen. The furnace temperature was continuously controlled so as to follow the standard time temperature curve within the accuracy specified in EN 1363-1:2020.

Enclosures 2.0 and 2.1	Furnace temperatures The actual minimum-, average- and maximum furnace temperature in relation to the standard temperature. The table also shows the area under the actual time-temperature curve as well as the area under the standard time-temperature curve
Enclosures 3.0 and 3.1	Vertical furnace pressure The differential pressure in the furnace during the test, measured 1,16 m above notional floor level
Enclosures 4.0 and 4.1	Ambient temperature The ambient temperature in the laboratory during the test
Enclosures 5.0 and 5.1	Average temperature rise Measured with 5 thermocouples on the unexposed side
Enclosures 6.0 and 6.1	Maximum temperature rise Maximum temperatures on the unexposed side
Enclosures 7.0 and 7.1	Horizontal deformation Negative values indicate movement towards the furnace
Enclosures 8.0 and 8.1	Internal temperature - between chip board and fiber gypsum Unexposed Mid height

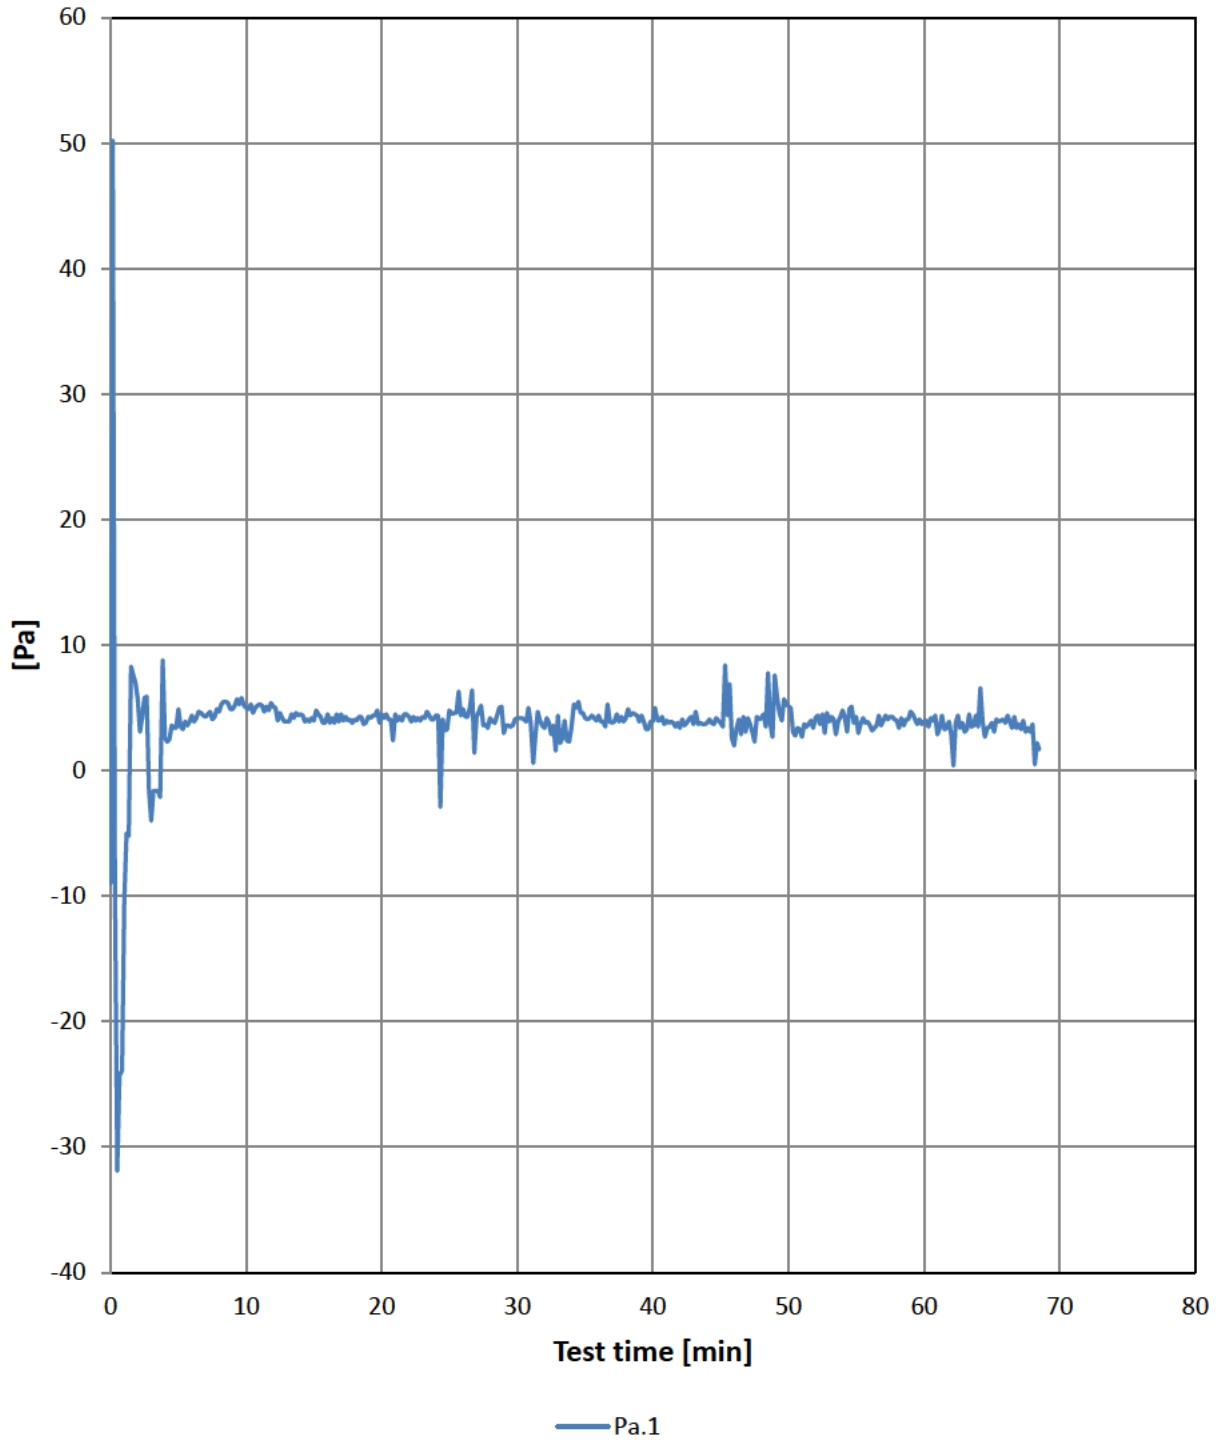
Vertical furnace pressure

The differential pressure in the furnace during the test, measured 1,16 m above notional floor level

The furnace pressure was controlled at a level of 20 Pa at the top of the test specimen during the test.

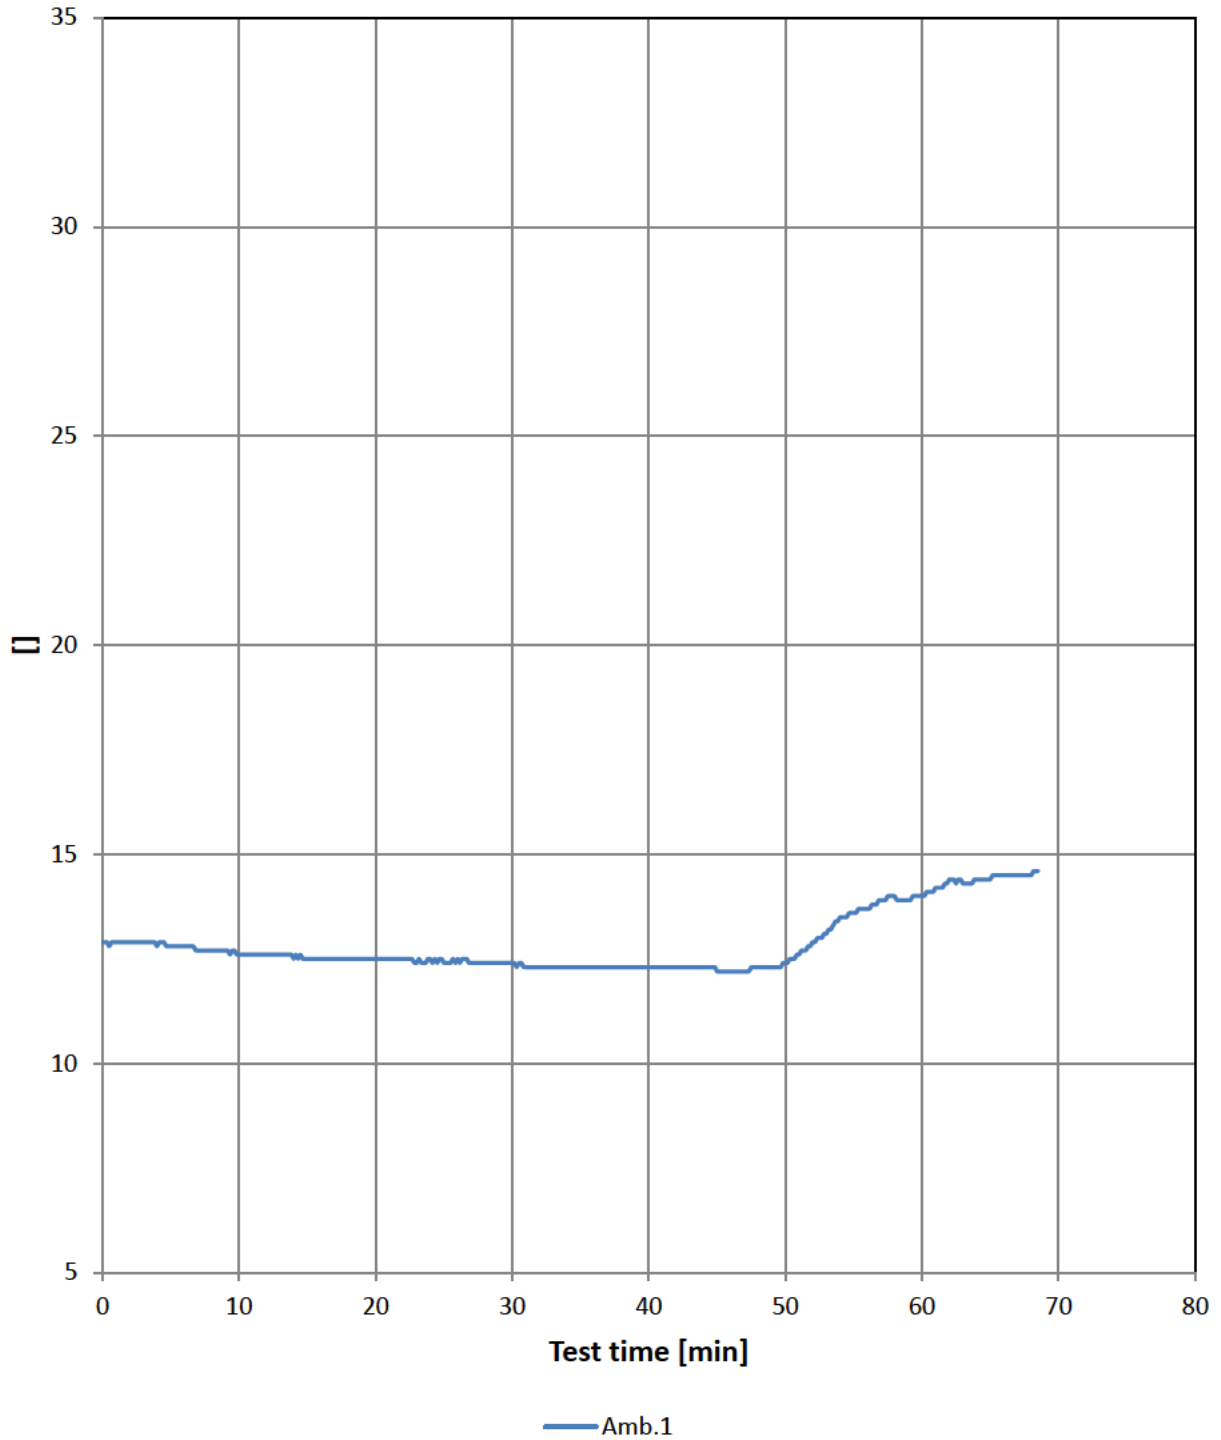
Ambient temperature

The ambient temperature in the laboratory during the test

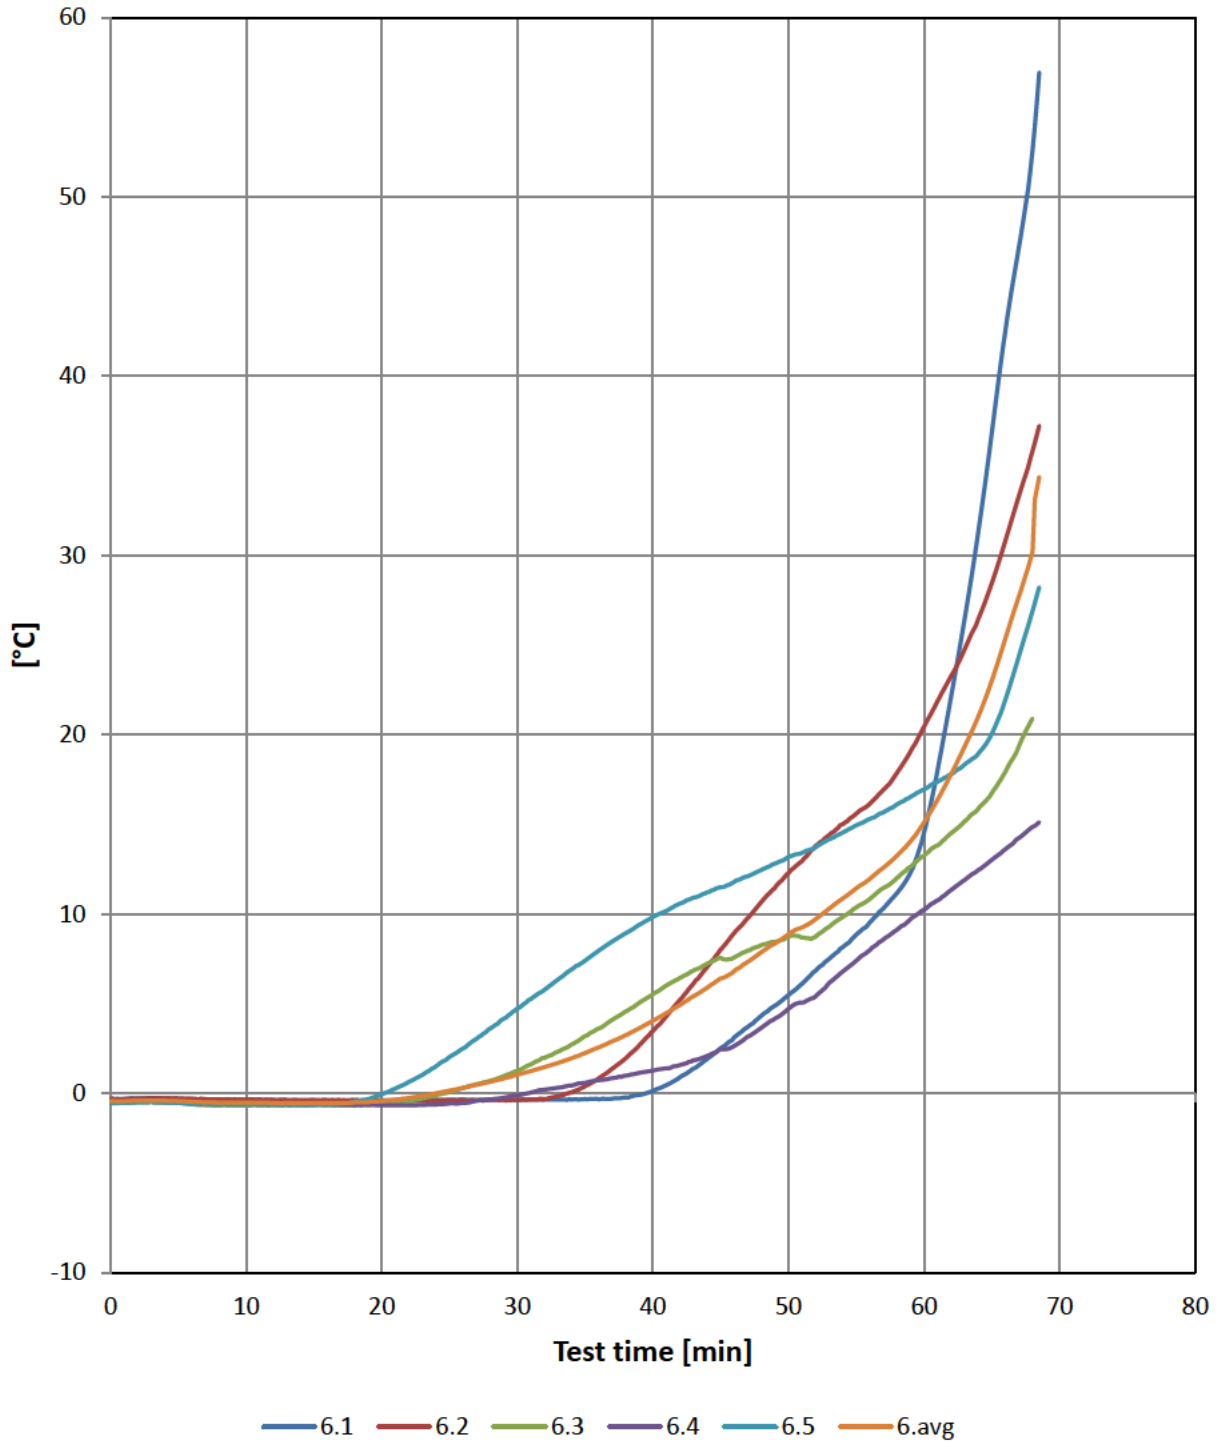
Average temperature rise

Measured with 5 thermocouples on the unexposed side

- Failure of insulation occurred after 64 minutes of testing due to failure of integrity.
- The mean temperature rise measured on the unexposed surface of the test specimen did not exceed 140 °C during the test. The mean temperature rise was 43 °C.
- The maximum temperature rise measured on the unexposed surface of the test specimen did not exceed 180 °C during the test. The maximum temperature rise was 98 °C.
