TEST REPORT NON-LOADBEARING WALL

Name of sponsor:	Wood:UpHigh		
Product name:	Non-loadbearing wall		
File no.:	PGA12234A	Revision no.:	0
Test date:	2023-01-27	Date:	2023-07-10
Pages:	9	Encl.:	41
Ref:	JBK / CHB

Examination of the fire-resistance of one symmetrical partition wall with timber frames.

The test specimen was a double timber frame construction with gypsum boards, particle boards and grass fiber insulation. The test specimen was symmetrical.

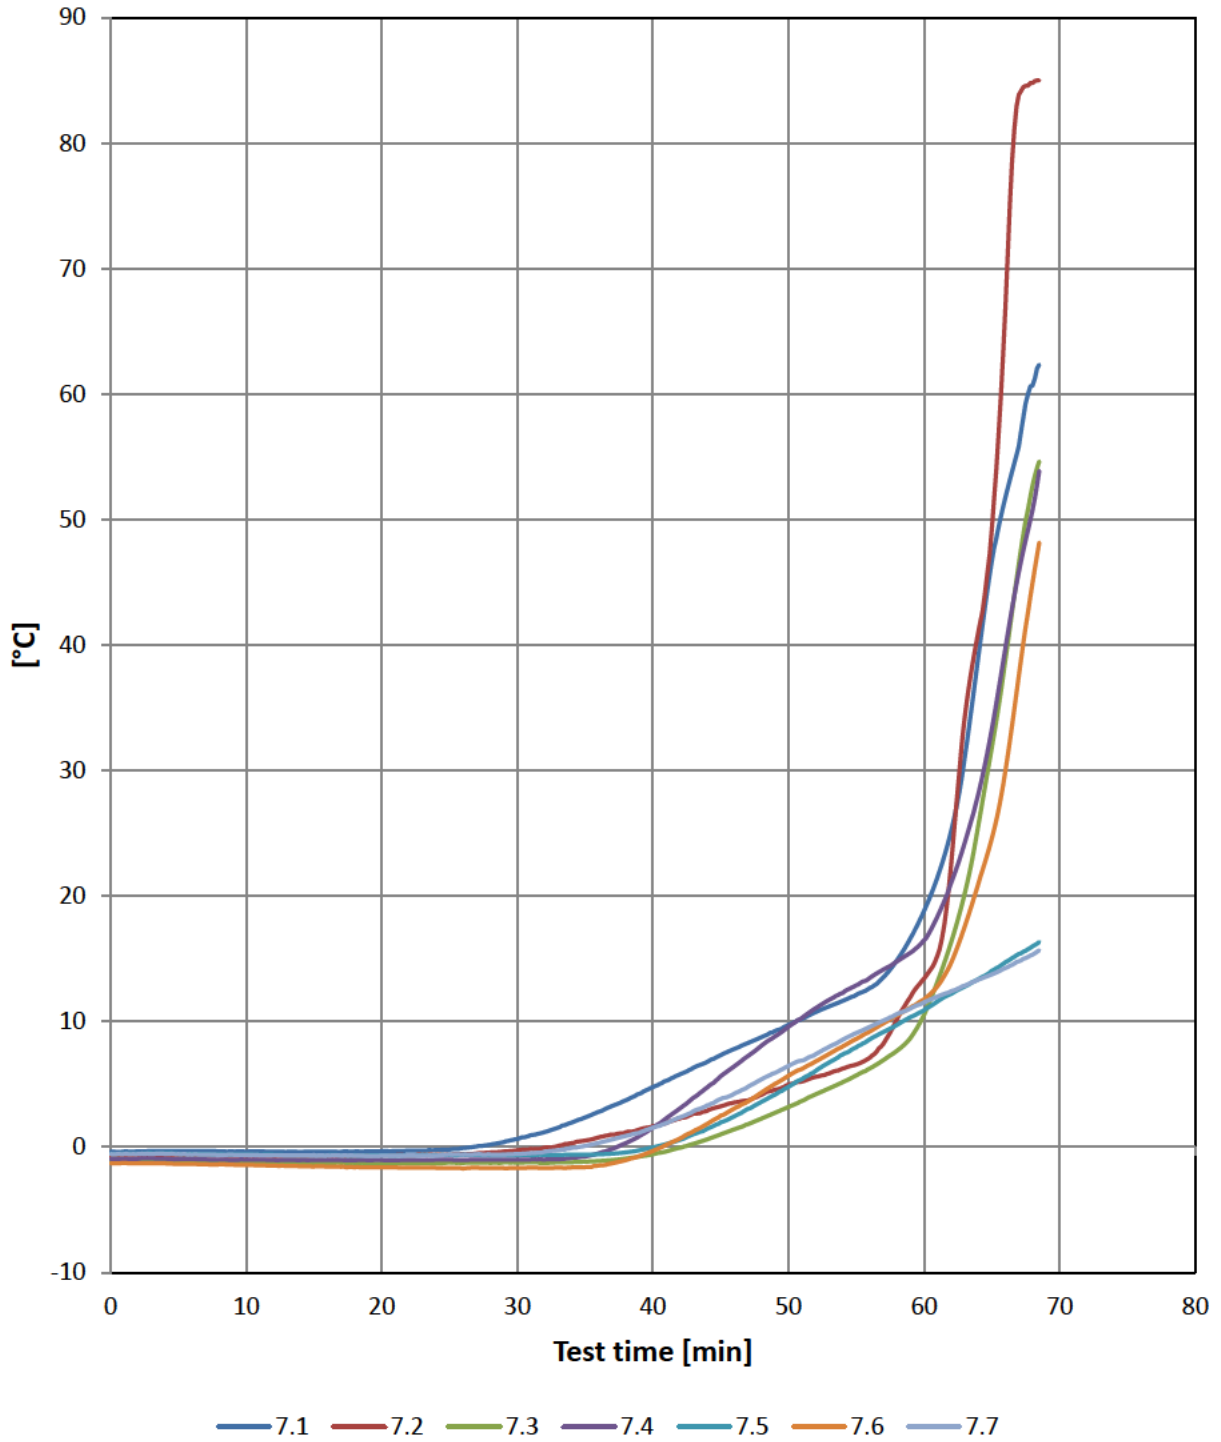
Maximum temperature rise

Maximum temperatures on the unexposed side

- Failure of insulation occurred after 64 minutes of testing due to failure of integrity.
- The mean temperature rise measured on the unexposed surface of the test specimen did not exceed 140 °C during the test. The mean temperature rise was 43 °C.
- The maximum temperature rise measured on the unexposed surface of the test specimen did not exceed 180 °C during the test. The maximum temperature rise was 98 °C.

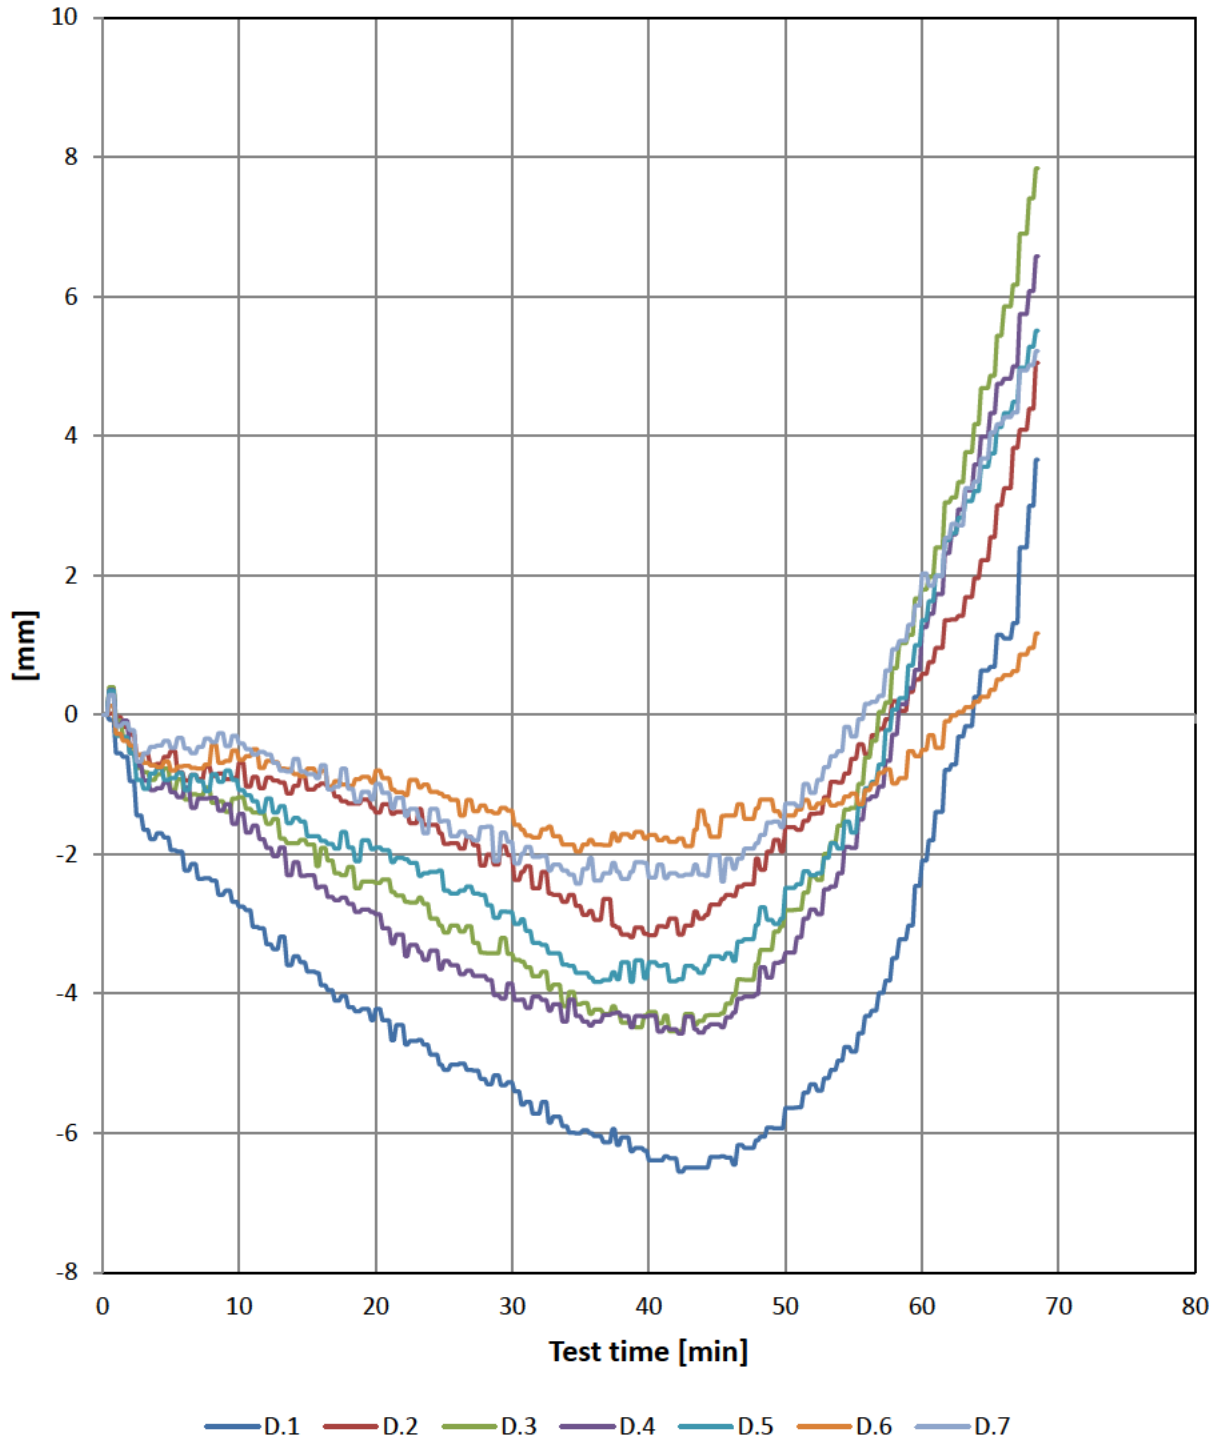
Horizontal deformation

Negative values indicate movement towards the furnace

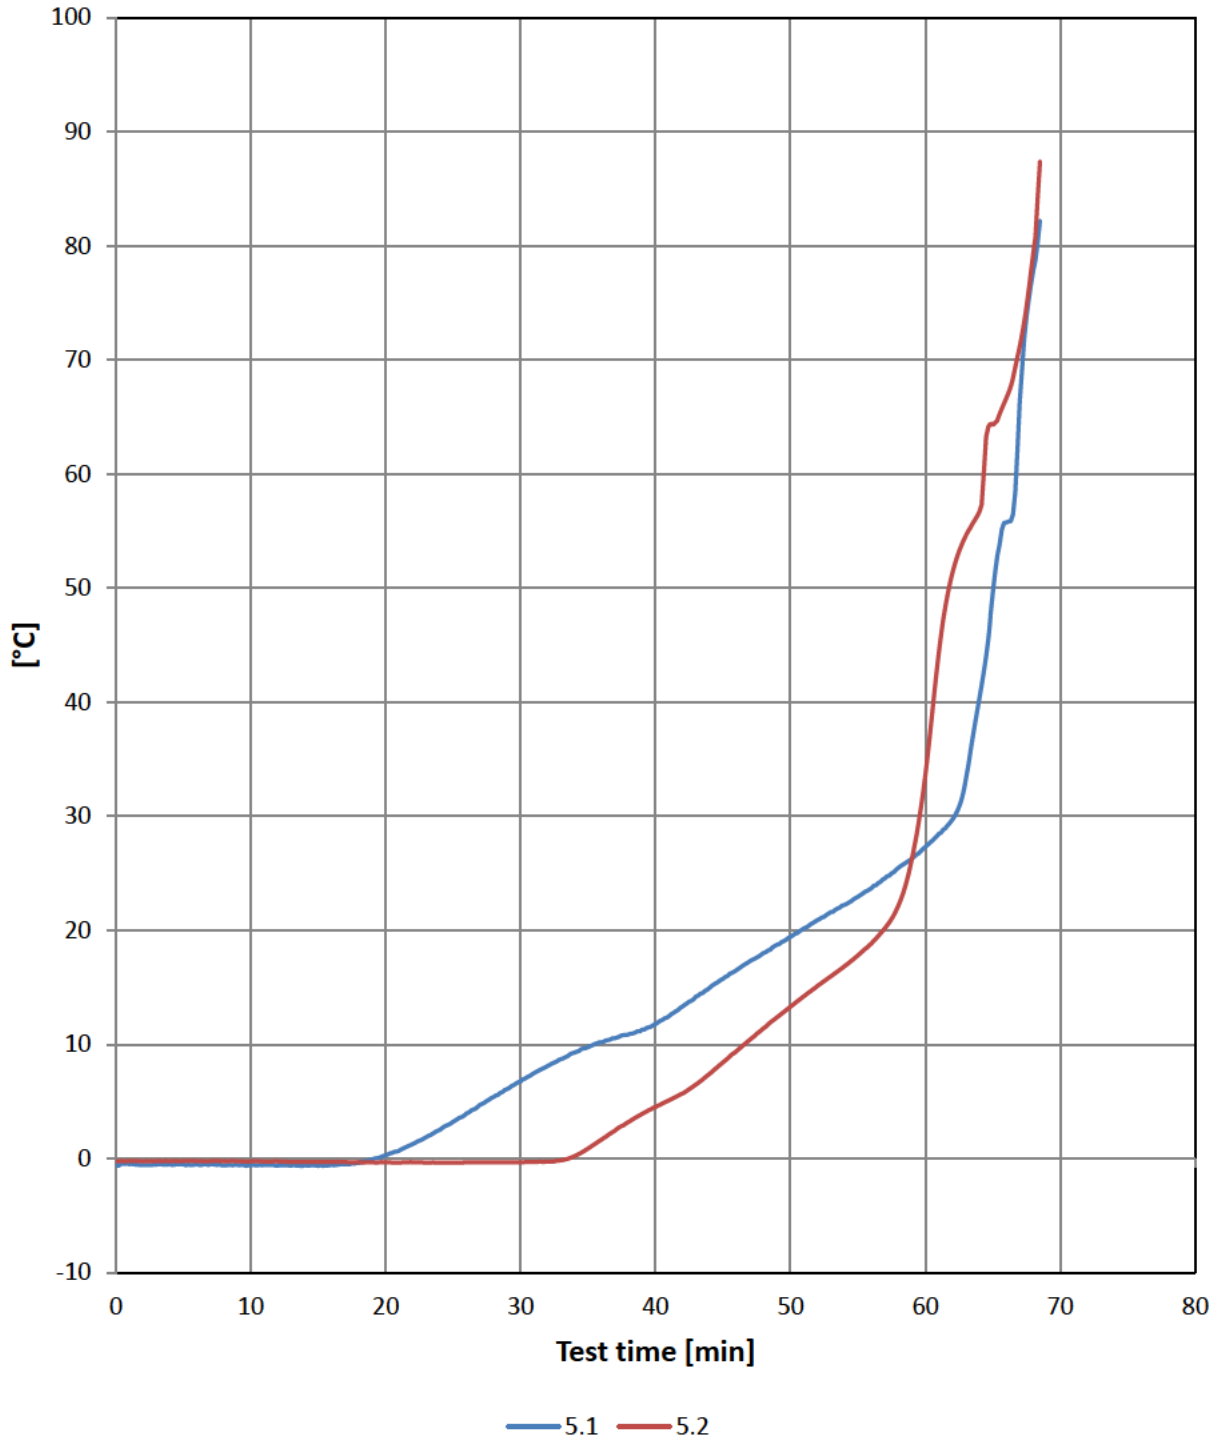
Internal temperature - between chip board and fiber gypsum Unexposed

Mid height

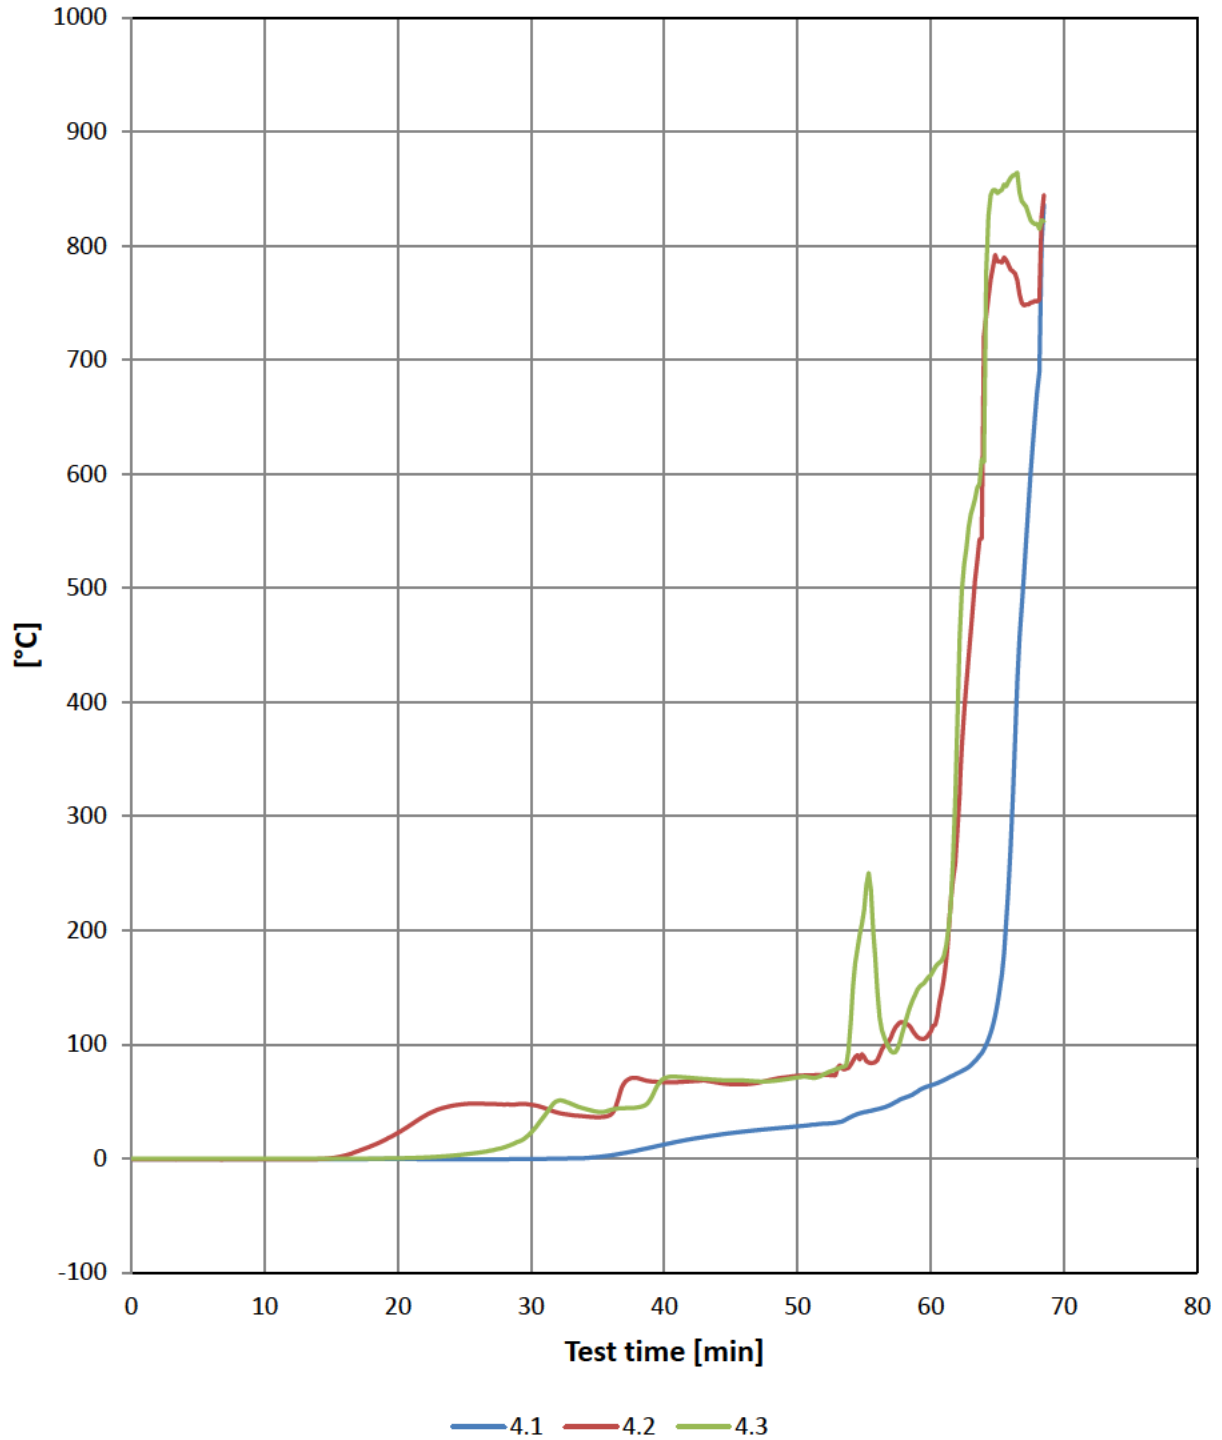
Internal temperature - between studs and chip board Unexposed

Mid height, 1 on third stud fom right, 2 and 3 on insulation to the left of 1 seen from unexposed side

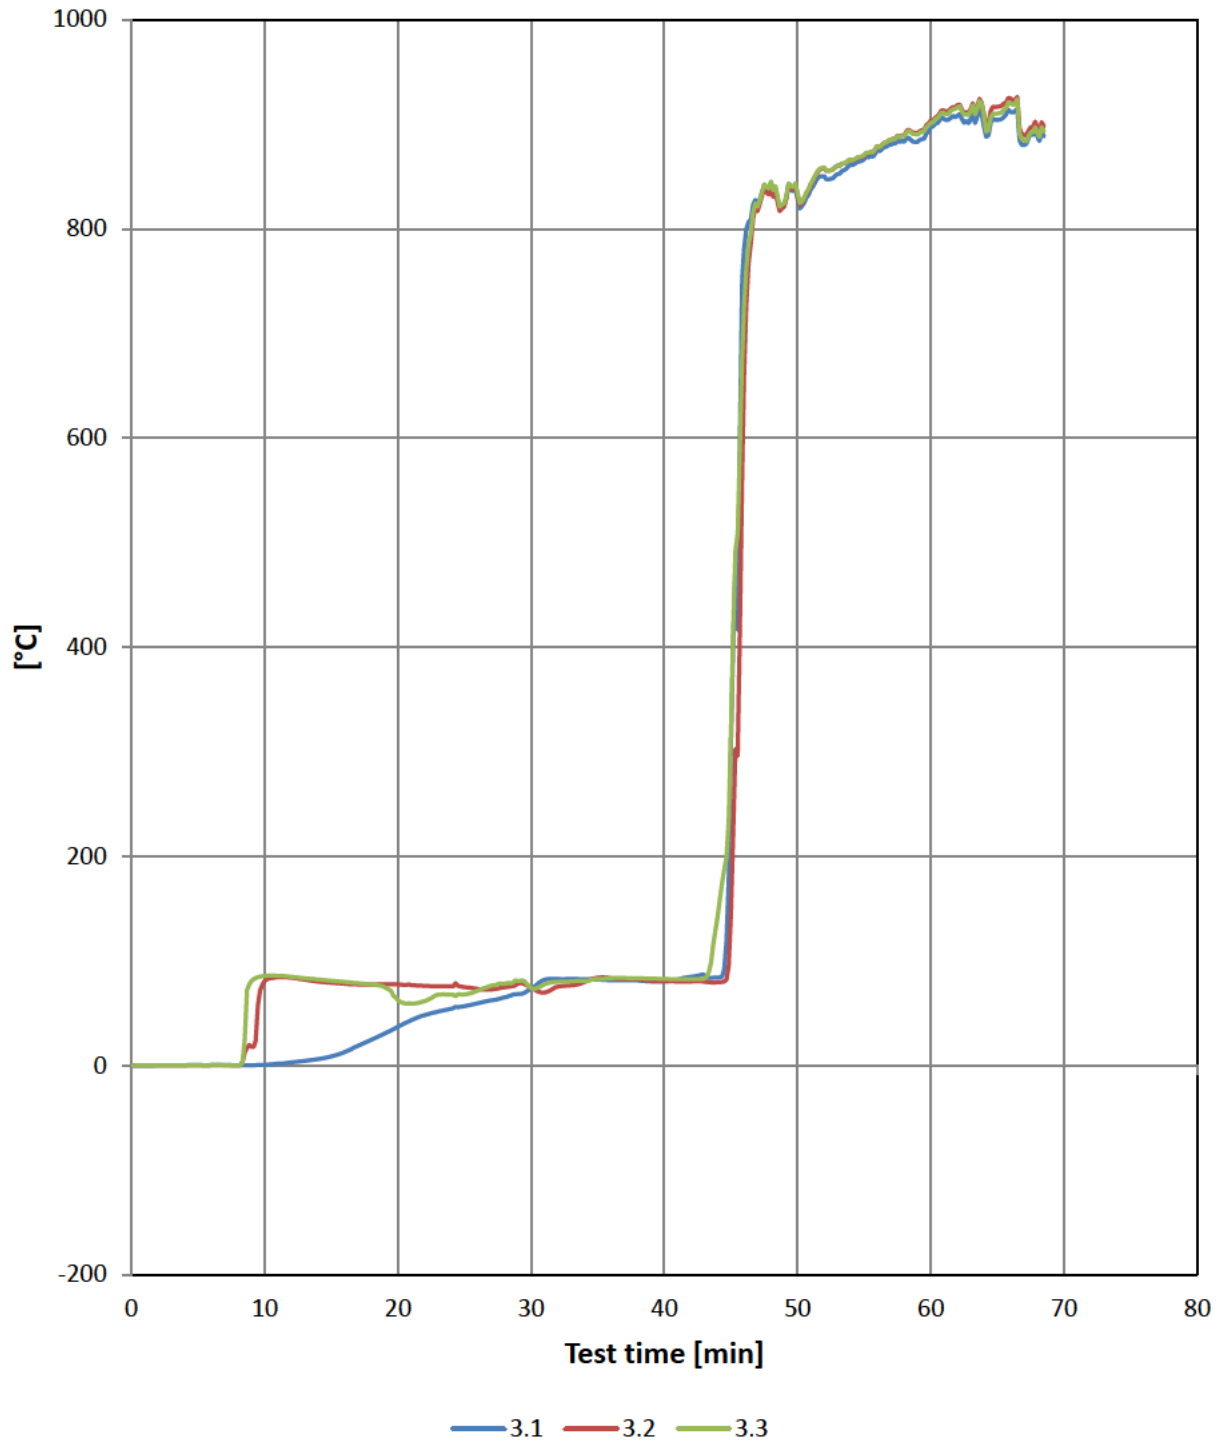
Internal temperature - between insulation layers

at mid height, 1 and 3 on insulation, 2 on center stud seen from exposed side.

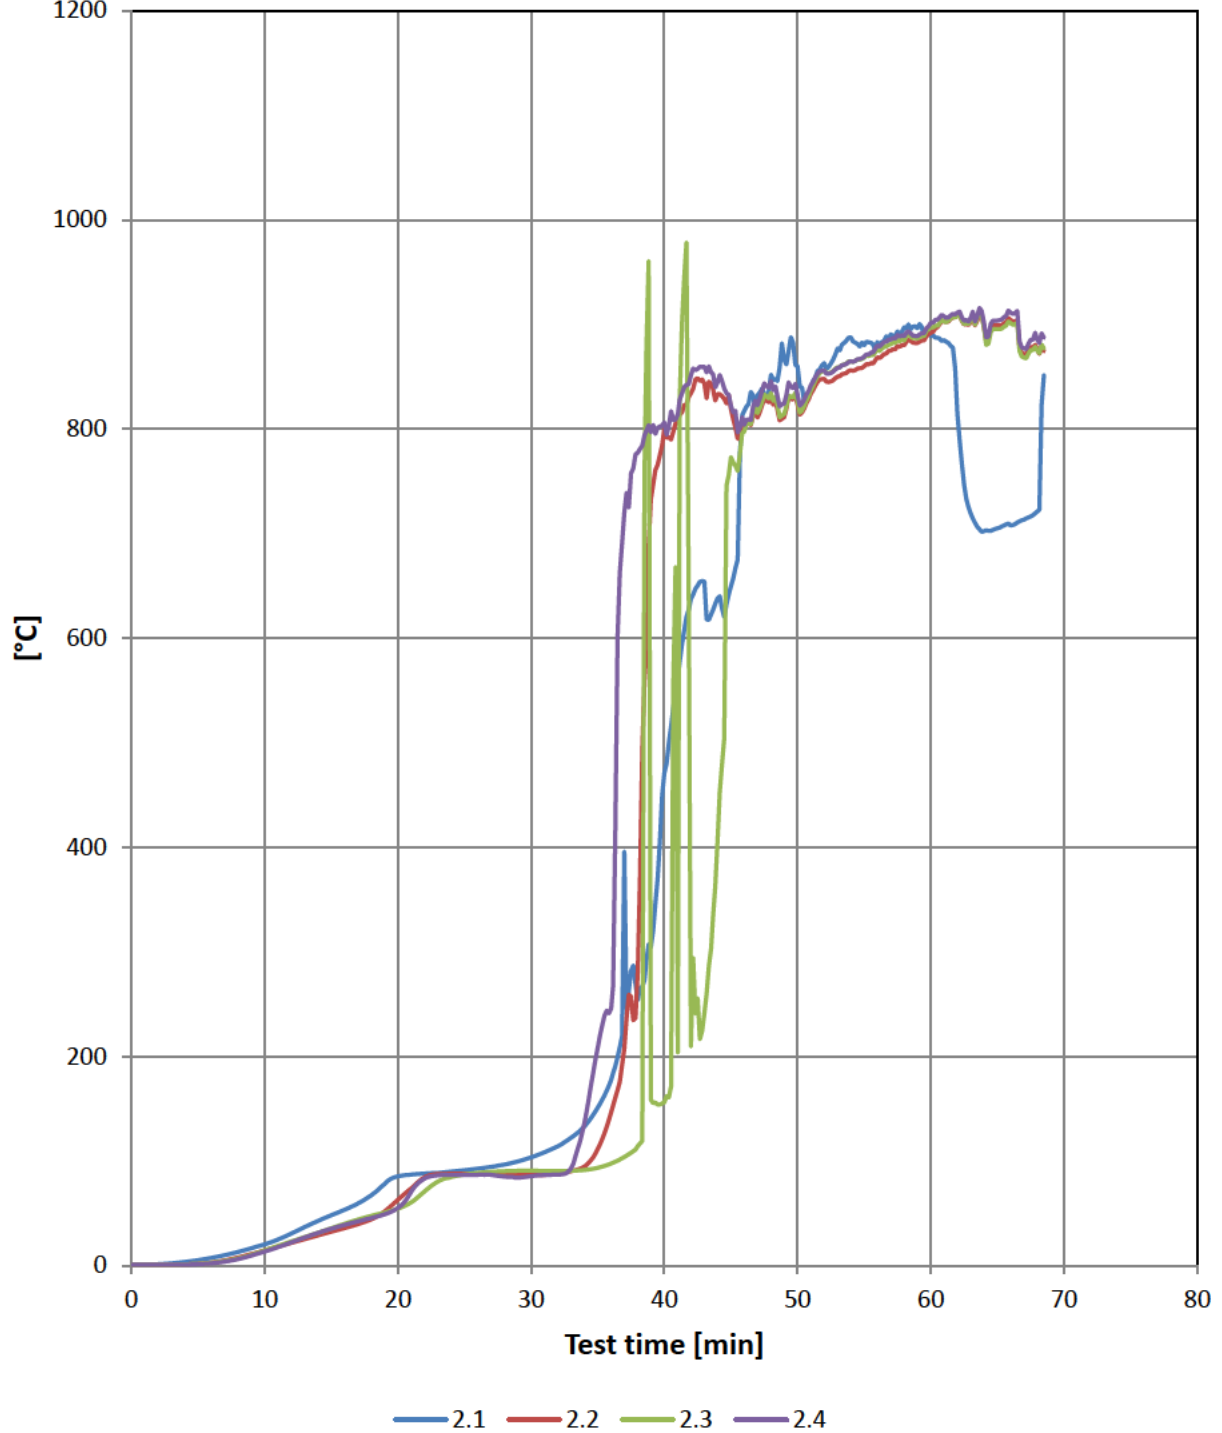
Internal temperature - between studs and chipboard exposed

1,2 and 4 on second stud at mid height, 3 on center stud at height 2460 mm seen from exposed side

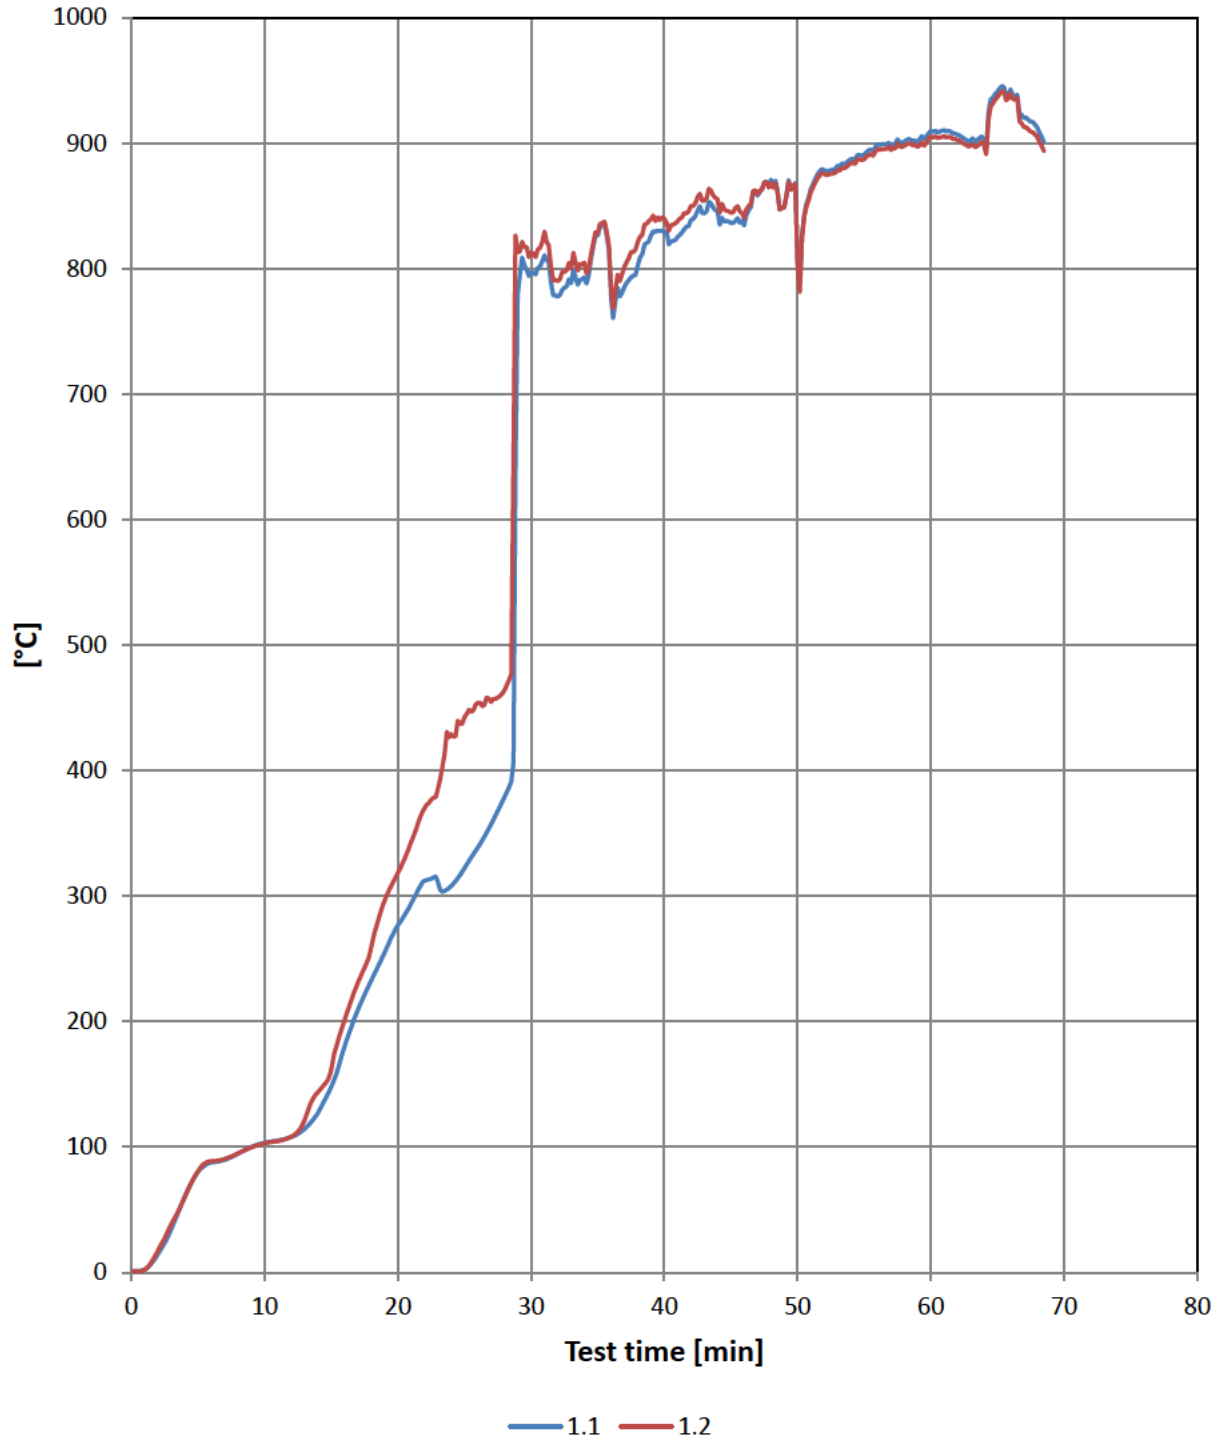
Internal temperature - Between chipboard and fiber gypsum Exposed

placed in 1/4 points between chipboard and fibergypsum

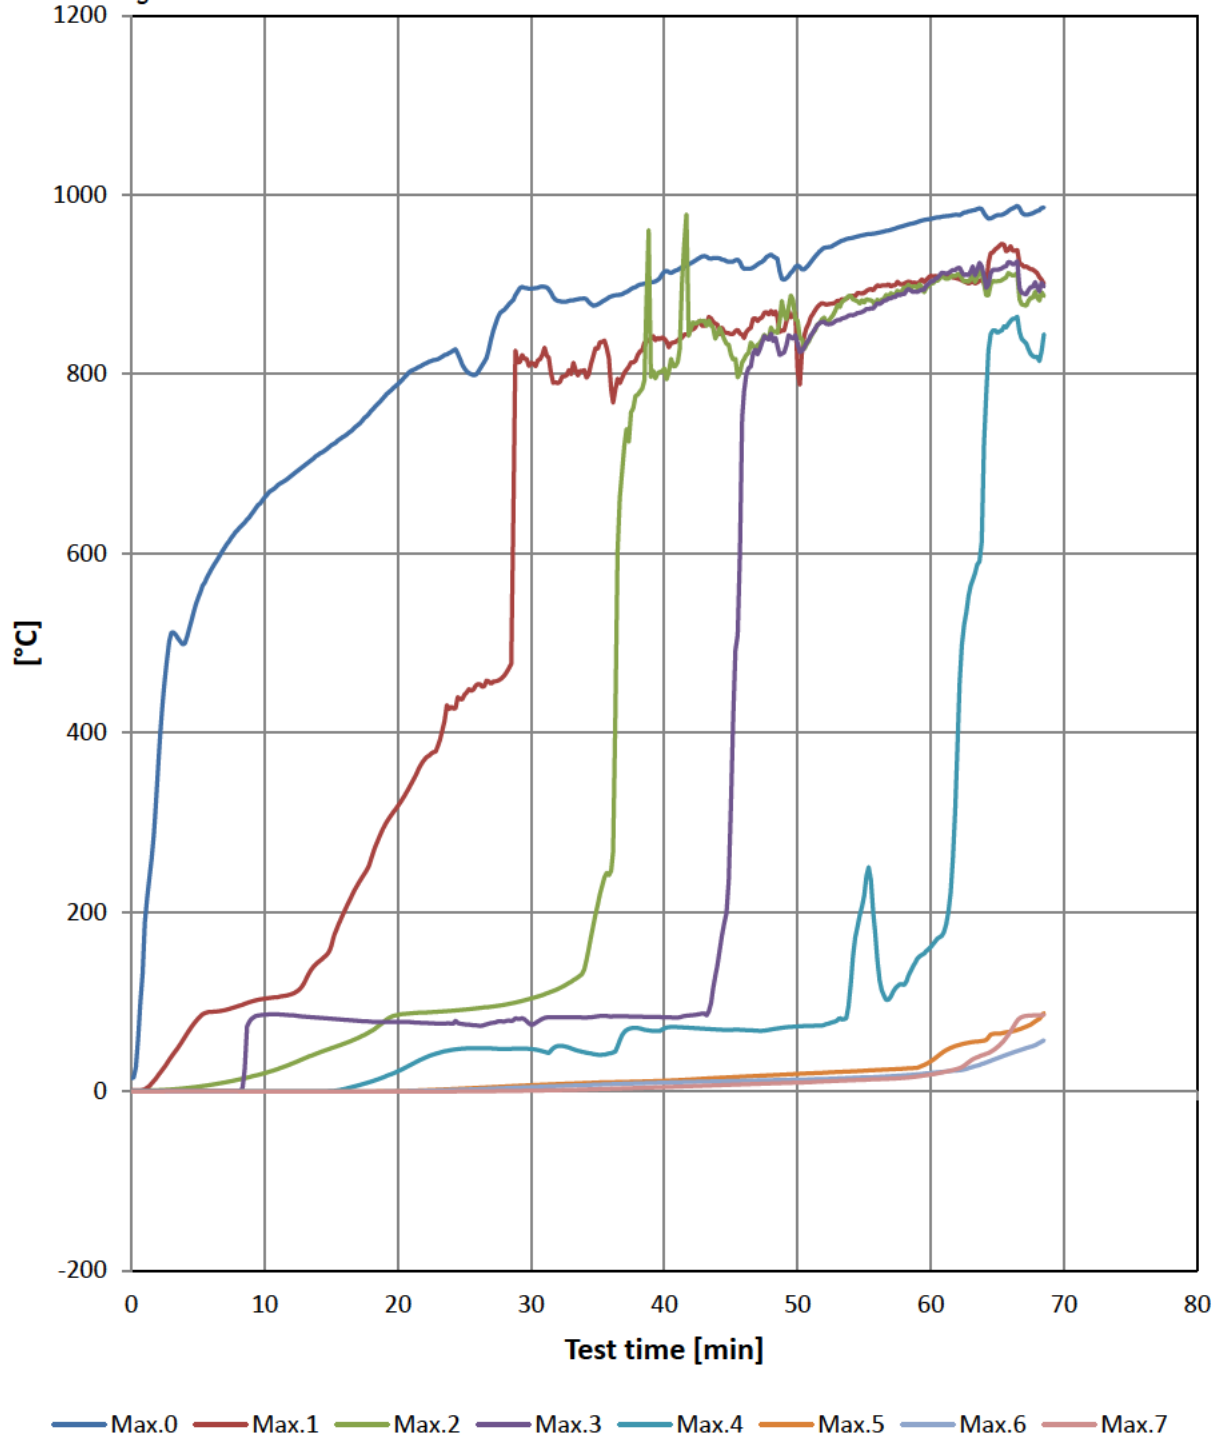
Maximum temperature between the construction layers

Each data serie corresponds to the maximum temperature of all thermocouples in that layer. See drawing 1.7

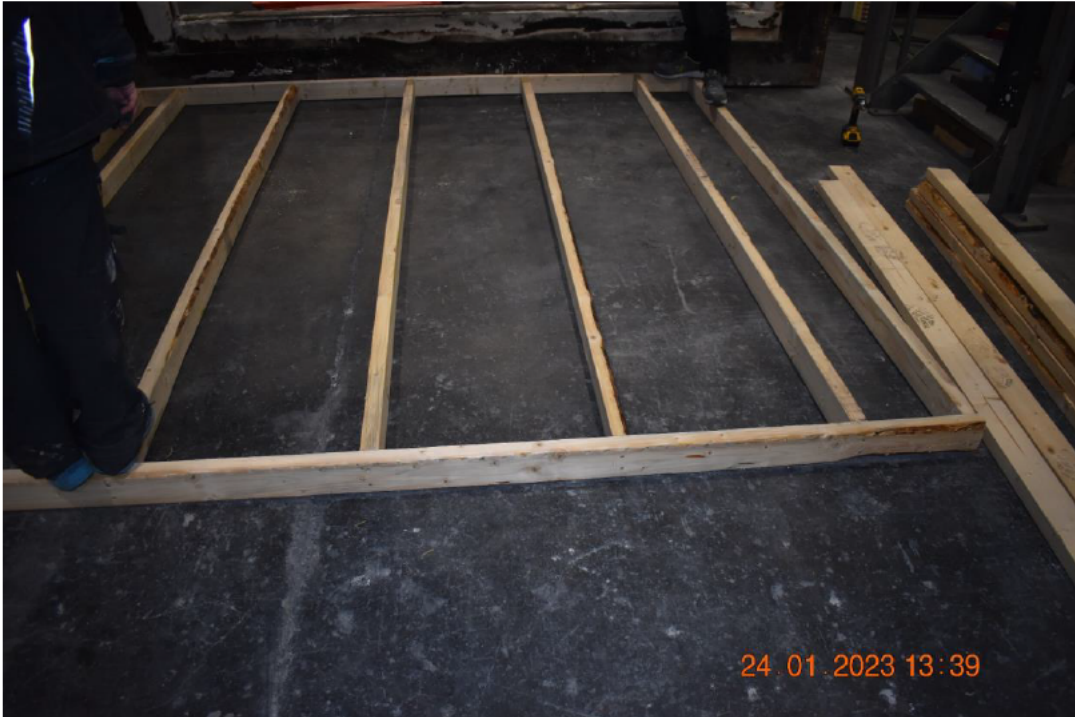
Photo No. 1 Wooden structure during assembly

See drawing no. 1.1 and 1.2 and photo no. 1.

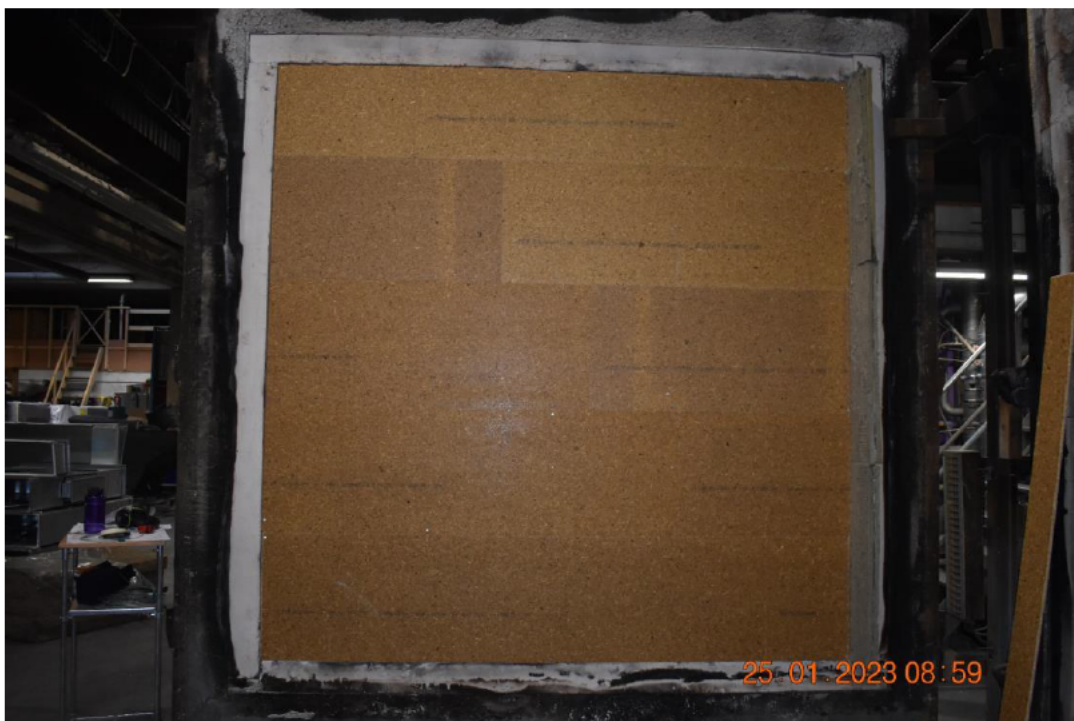
Photo No. 4 Test specimen seen from exposed side during mounting

See drawing no. 1.2 and 1.5 and photo no. 4 and 8.

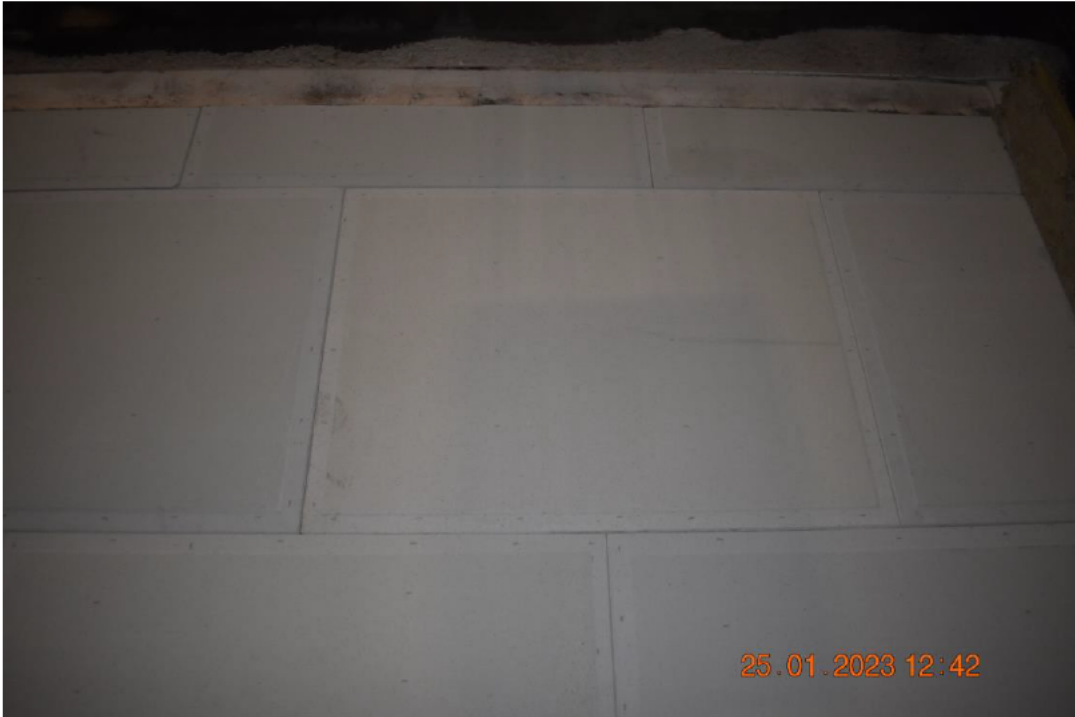
Photo No. 5 Test specimen seen from unexposed side during mounting

was cut to size in between the studs. See photo no. 5.

See drawing no. 1.1 and 1.6 and photos no. 5 and 9.

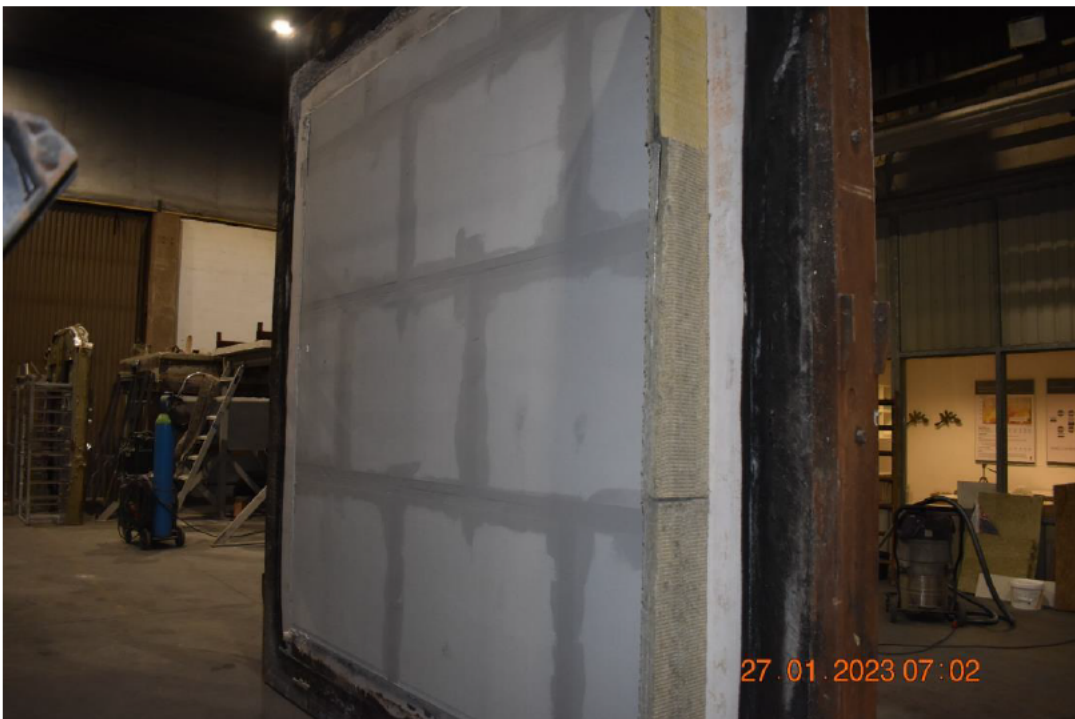
Photo No. 6 Test specimen seen from exposed side during mounting

Filler Over the board joints filler designated [REDACTED] was used. See photo 6 and 10.

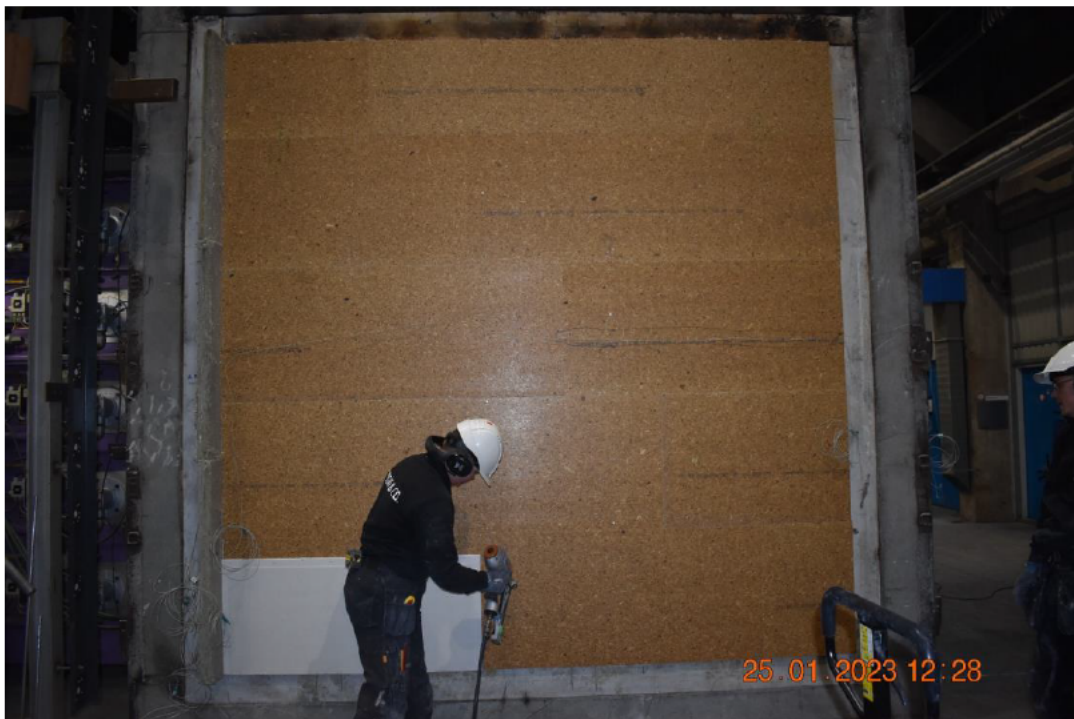
Photo No. 8 Test specimen seen from unexposed side during mounting

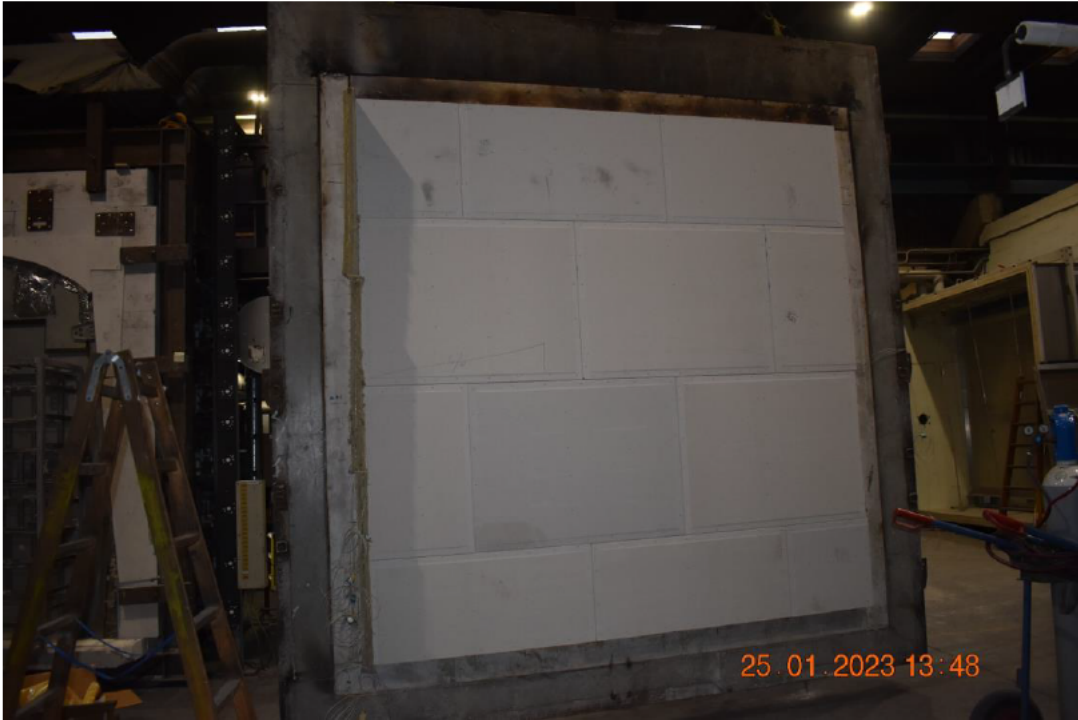
Photo No. 9 Test specimen seen from unexposed side during mounting

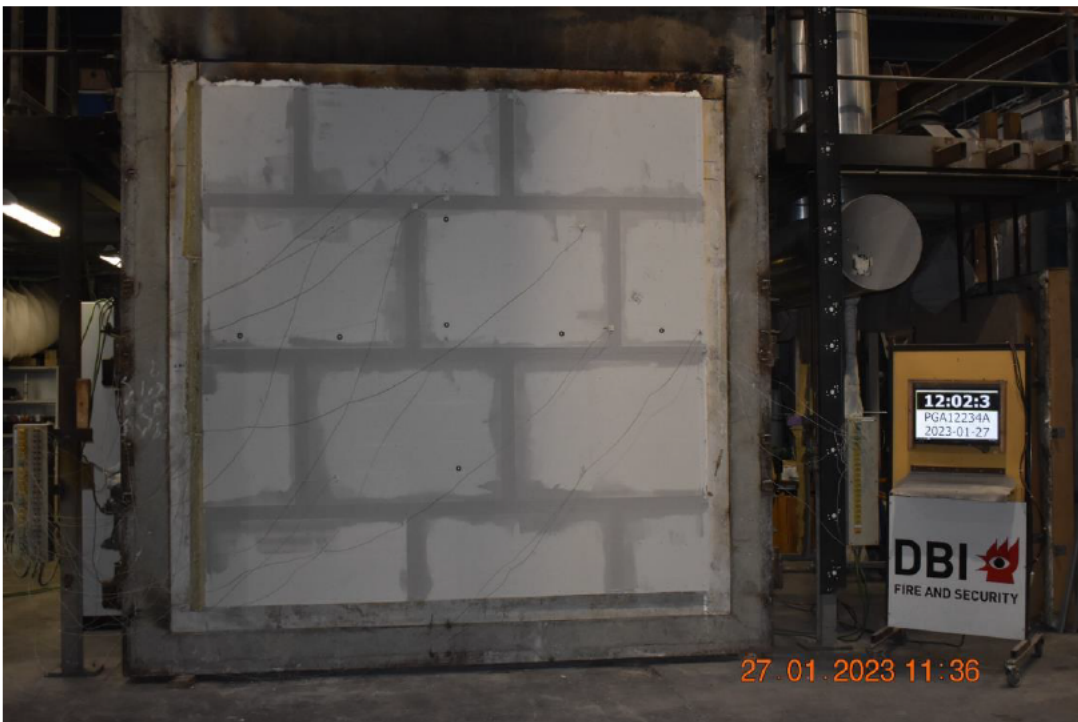
Photo No. 10 Test specimen seen from unexposed side before test start

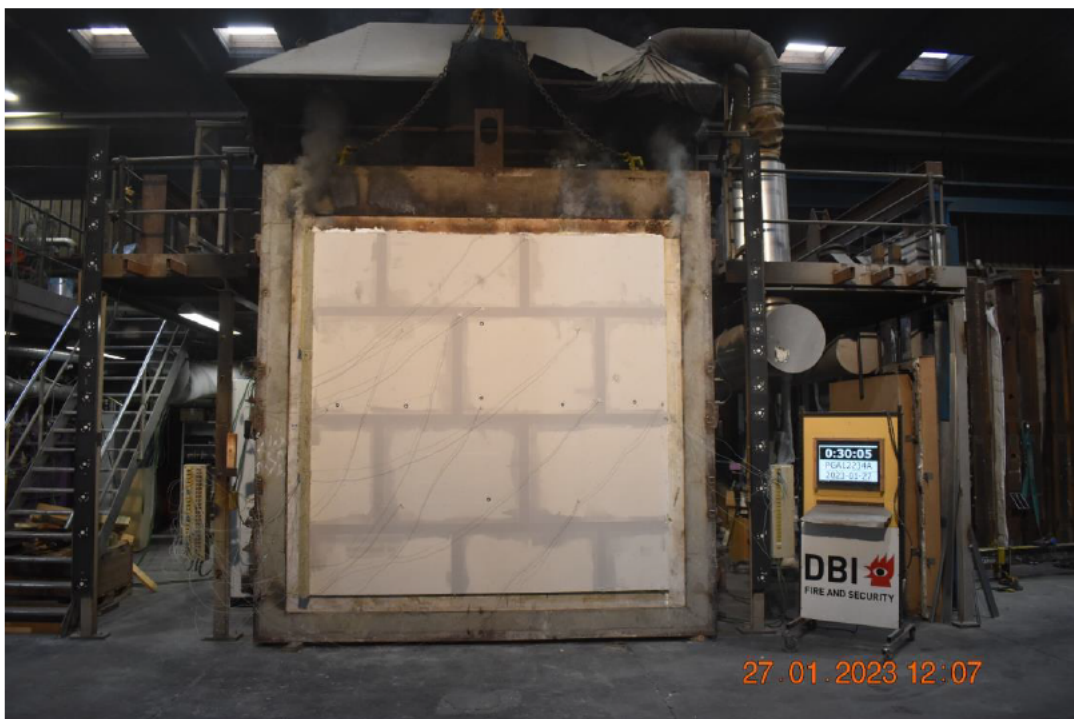
Photo No. 12 Test specimen seen from unexposed side 30 minutes into the test

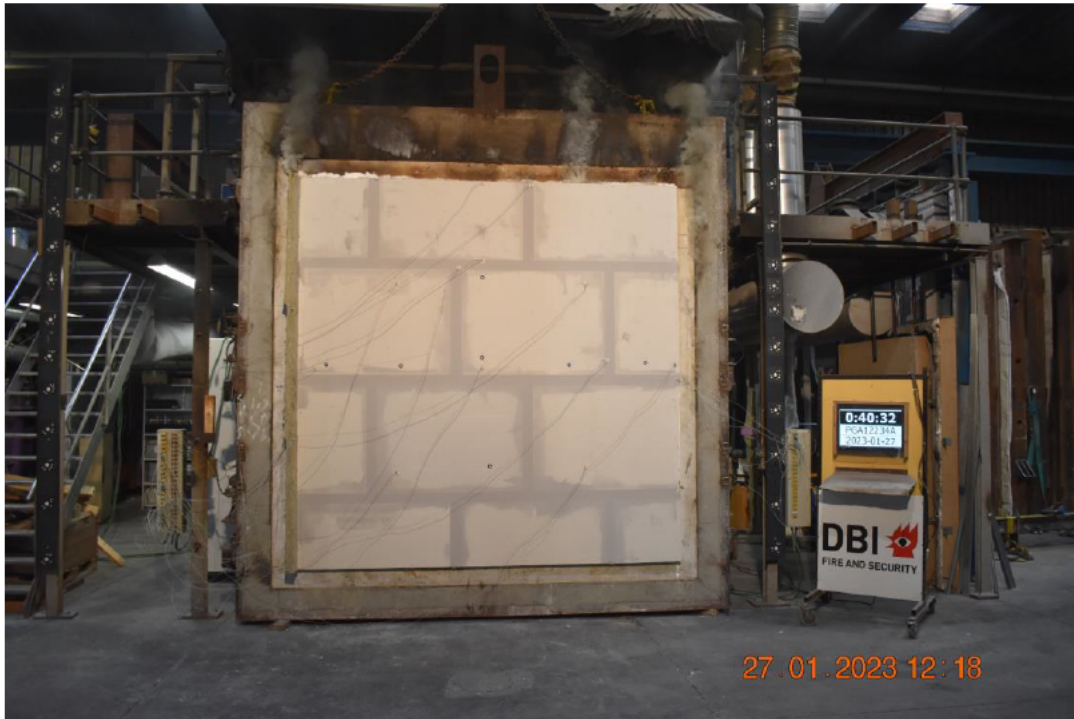
Photo No. 13 Test specimen seen from unexposed side 40 minutes into the test

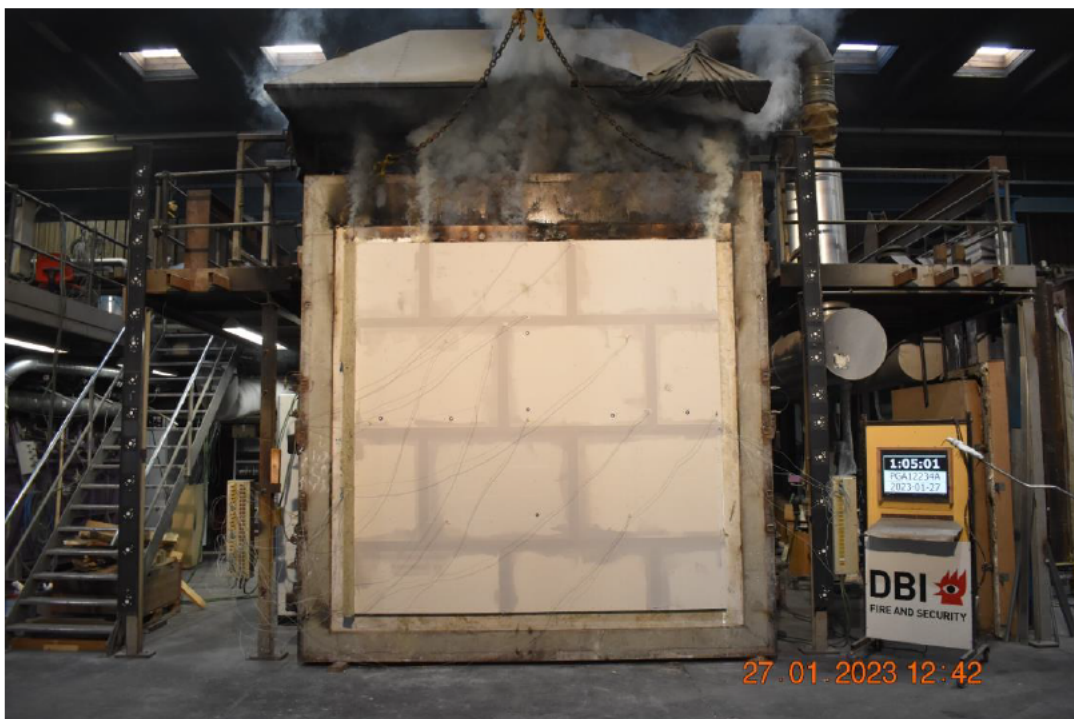
Photo No. 14 Test specimen seen from unexposed side 65 minutes into the test

- Sustained flaming occurred after 64 minutes of testing.
- The cotton pad was ignited after 64 minutes of testing.
- No through-going openings in the test specimen were created during the test.
