TEST REPORT NON-LOADBEARING WALL

Name of sponsor:	Wood:UpHigh		
Product name:	Non-loadbearing wall		
File no.:	PGA12234A	Revision no.:	0
Test date:	2023-01-27	Date:	2023-07-10
Pages:	9	Encl.:	41
Ref:	JBK / CHB

Examination of the fire-resistance of one symmetrical partition wall with timber frames.

The test specimen was a double timber frame construction with gypsum boards, particle boards and grass fiber insulation. The test specimen was symmetrical.

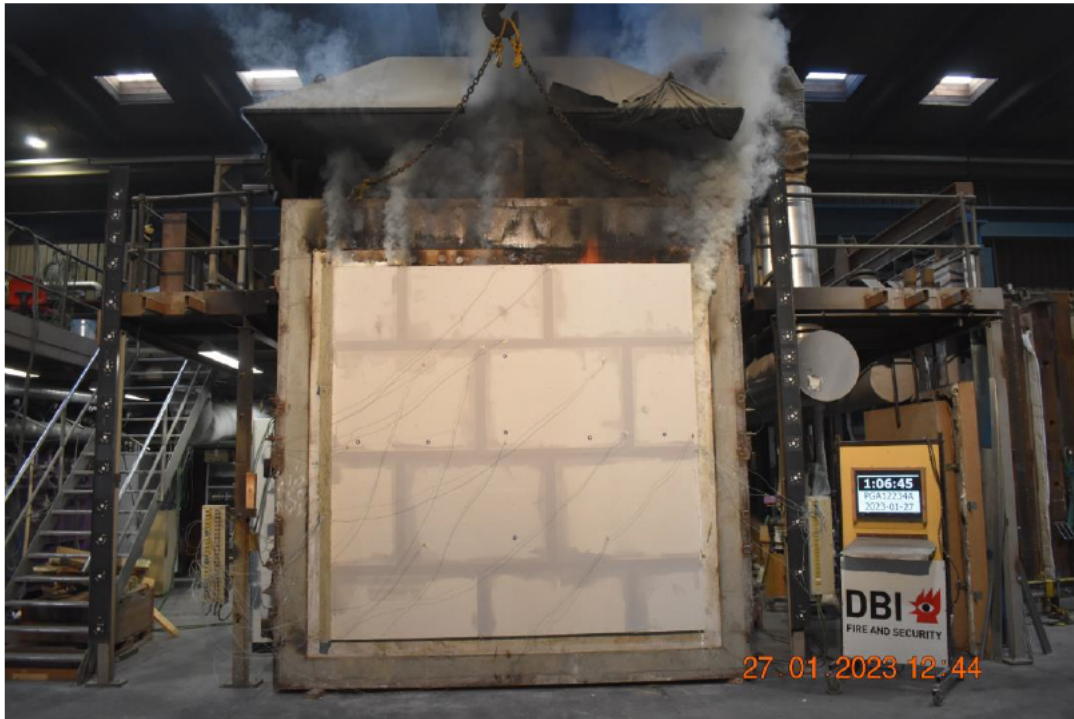
Photo No. 15 Test specimen seen from unexposed side 66 minutes into the test

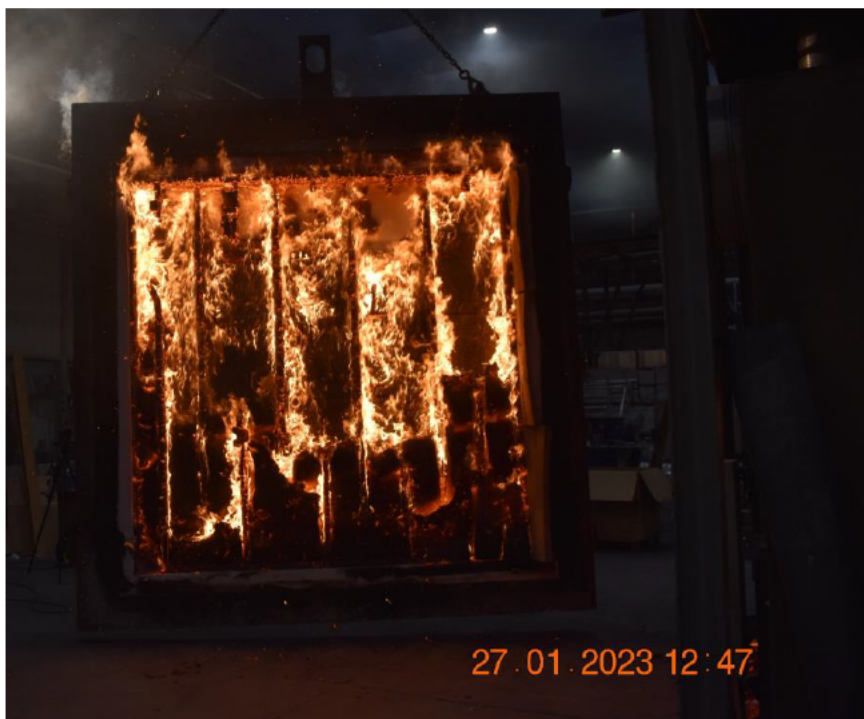
Photo No. 16 Test specimen seen from exposed side after the test

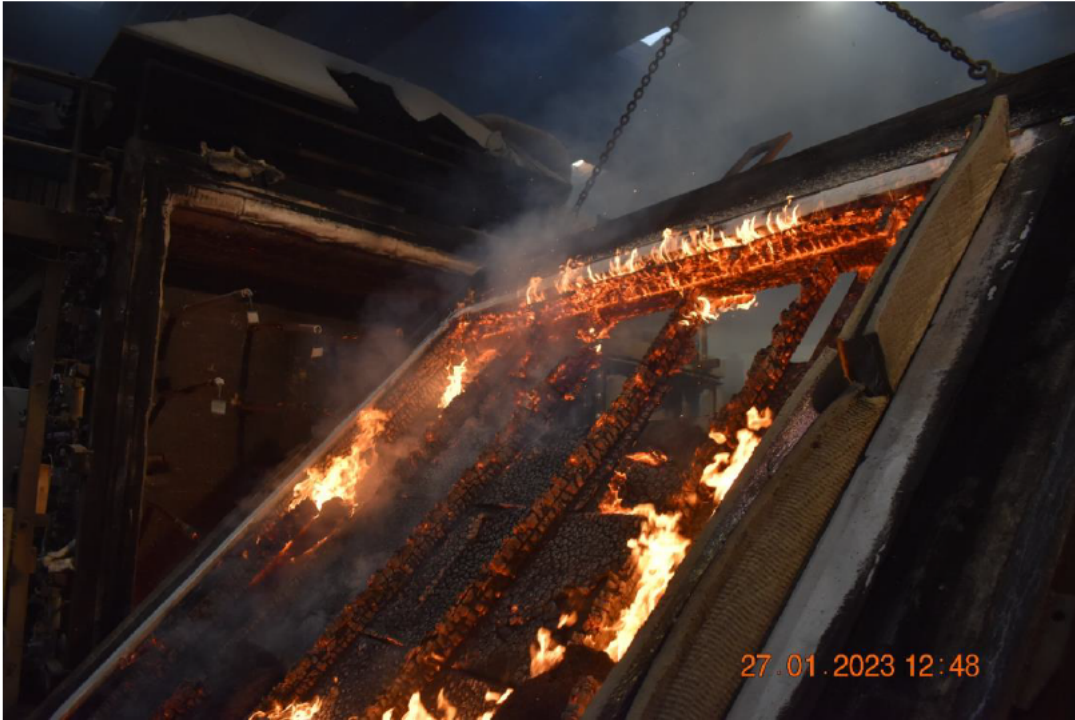
Photo No. 17 Test specimen seen from exposed side after the test

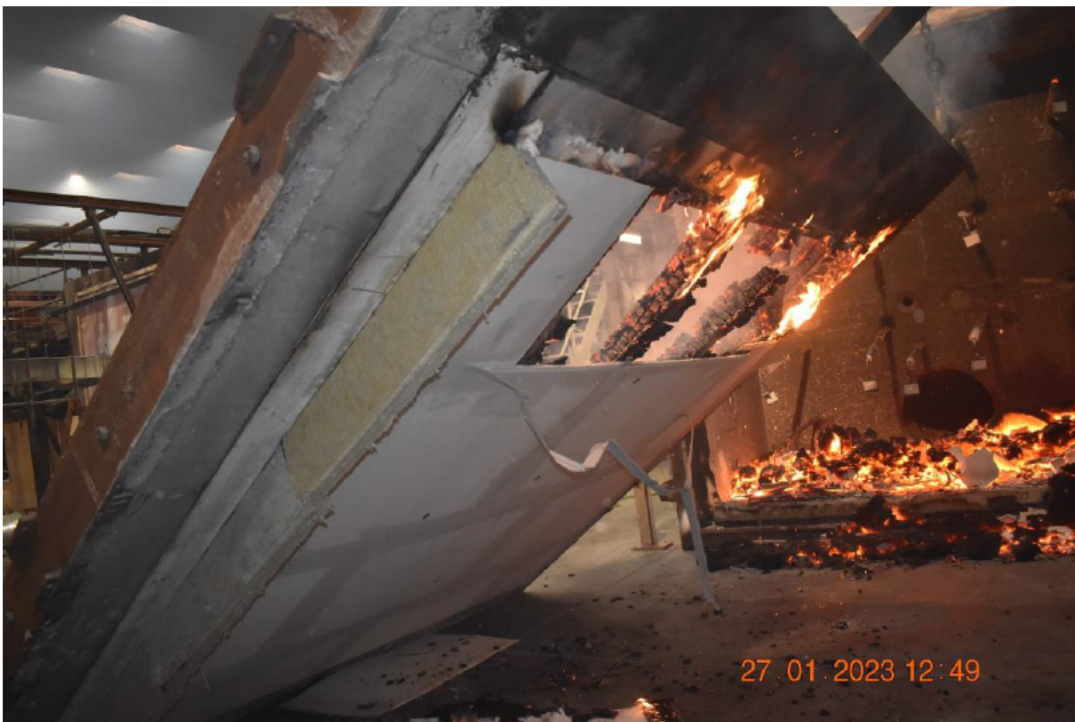
Photo No. 18 Test specimen seen from unexposed side after the test
